El puente atirantado sobre el río Suir en Waterford

Cable-stayed bridge across the River Suir at Waterford

El puente sobre el río Suir en Waterford (Irlanda) es un puente atirantado de 465 m de longitud con un vano principal de 230 m y una única torre. Este puente cuenta con una serie de características que lo hacen singular, entre las que cabe destacar su cimentación a base de micropilotes de gran capacidad de carga, su pilono con forma de Y invertida y sin riostra intermedia a la altura del tablero, el anclaje de los cables en el pilono a través de una estructura metálica interna, su tablero mixto consistente en un emparrillado metálico con dos o cuatro vigas de borde y vigas transversales y en losas nervadas de hormigón prefabricadas, la anchura variable del tablero o el hecho de que tenga una única junta de dilatación en uno de los estribos, siendo el otro estribo integral con el puente.

The bridge across the river Suir at Waterford (Ireland) is a cable-stayed bridge with 465 m total length, a 230 m long main span and a single pylon. This bridge has a number of characteristics which make it singular: the use of high capacity micropiles in the foundations, an inverted Y-shape

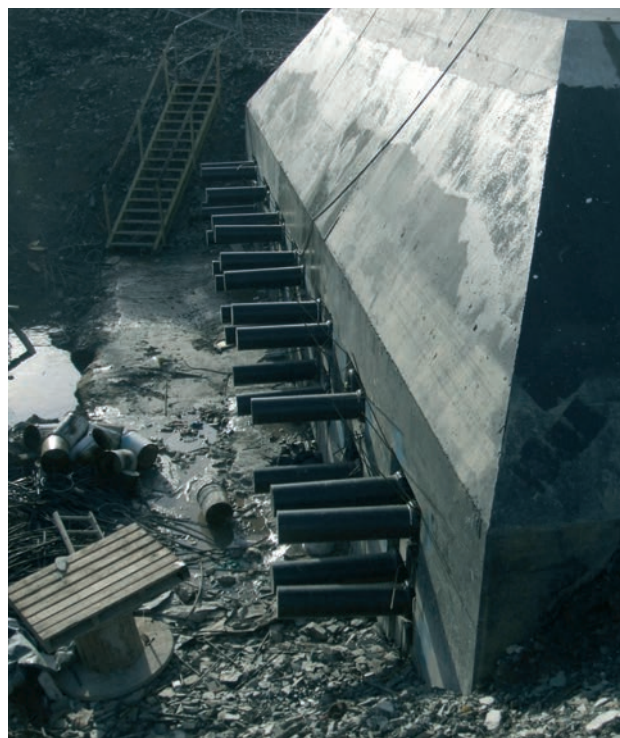
Figura 8. Anclajes del pretensado de la viga de atado
Figure 8. Anchorages for the tie beam prestressing

Because of the caution existing in British engineering community against interior prestressing, prestressing was designed as non adherent with wax filled polyethylene sheaths. The cables were electrically isolated from the anchorage plates and the possibility was left for the substitution of any strand in the future if, during an inspection, some movement of the foundations is detected. In addition, four more sheaths were installed (empty and sealed) to let the possibility of adding four more prestressing cables to the tie beam. The inspection of the tie beam is performed by means of 16 vibrating wire extensometers whose data are recorded in a continuous manner. If the foreseen values were surpassed at any time, an alarm would be generated to inform the bridge operator who would ask for correcting steps.

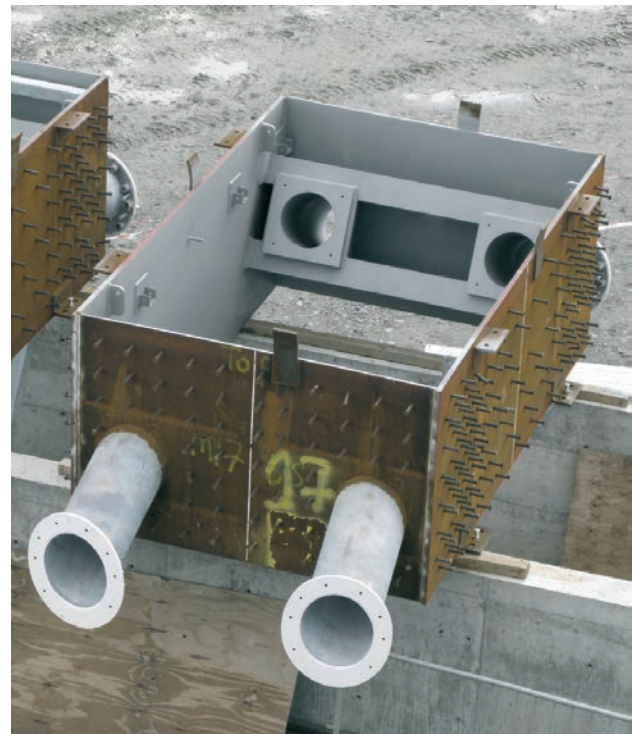
Figura 10. Cajón de anclaje de tirantes en torre
Figure 10. Anchorage box for the pylon

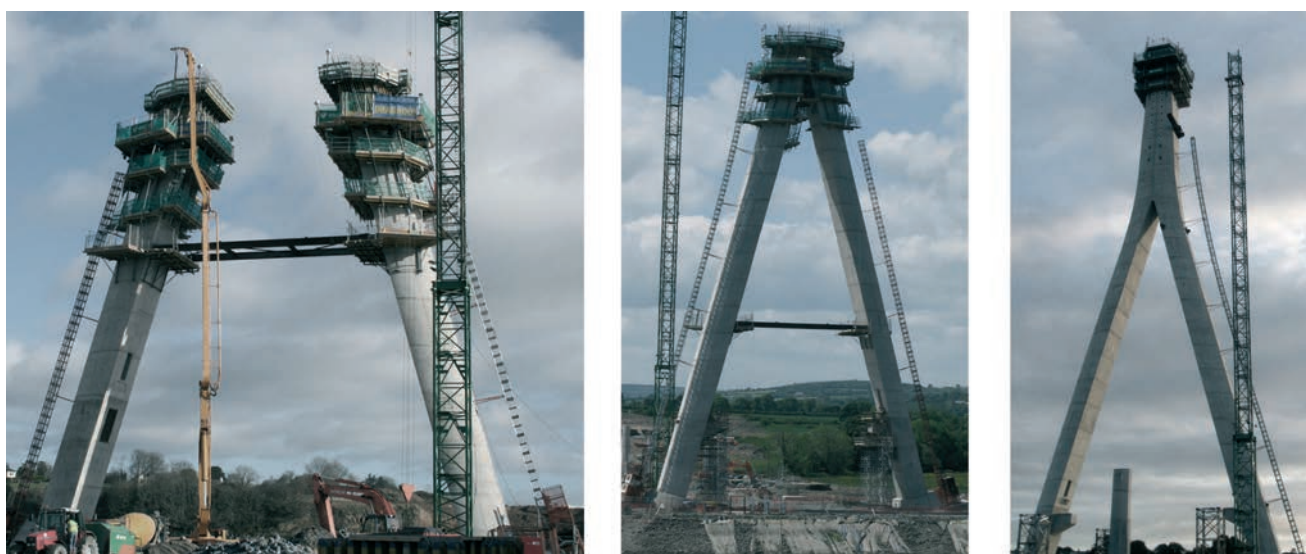
Figura 13. Distintas fases de construcción de la torre
Figure 13. Different stages in the construction of the pylon

La construcción de la torre se realizó mediante encofrado trepador en trepas de 4 m. Aunque la superficie exterior es curva, dado que el perfil curvo de la sección transversal se mantiene constante, sólo resultó necesario desmontar los encofrados en la zona de transición de patas a mástil, de directriz también curva, como se ha indicado anteriormente. La inclinación de las patas obligó a apuntalar una contra la otra mediante dos puntales horizontales, para limitar las flexiones en dichas patas (Figura 13). Uno de los puntales se situó a media altura y el otro en la intersección entre las patas.

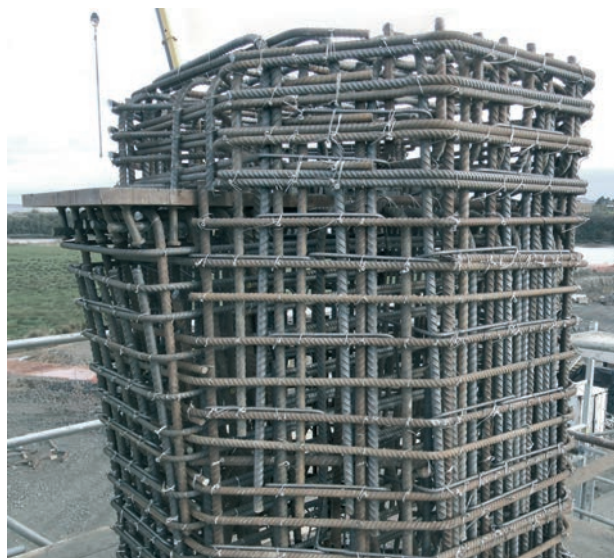
Figura 15. Armado de la cabeza de una pila
Figure 15. Reinforcement of one pier

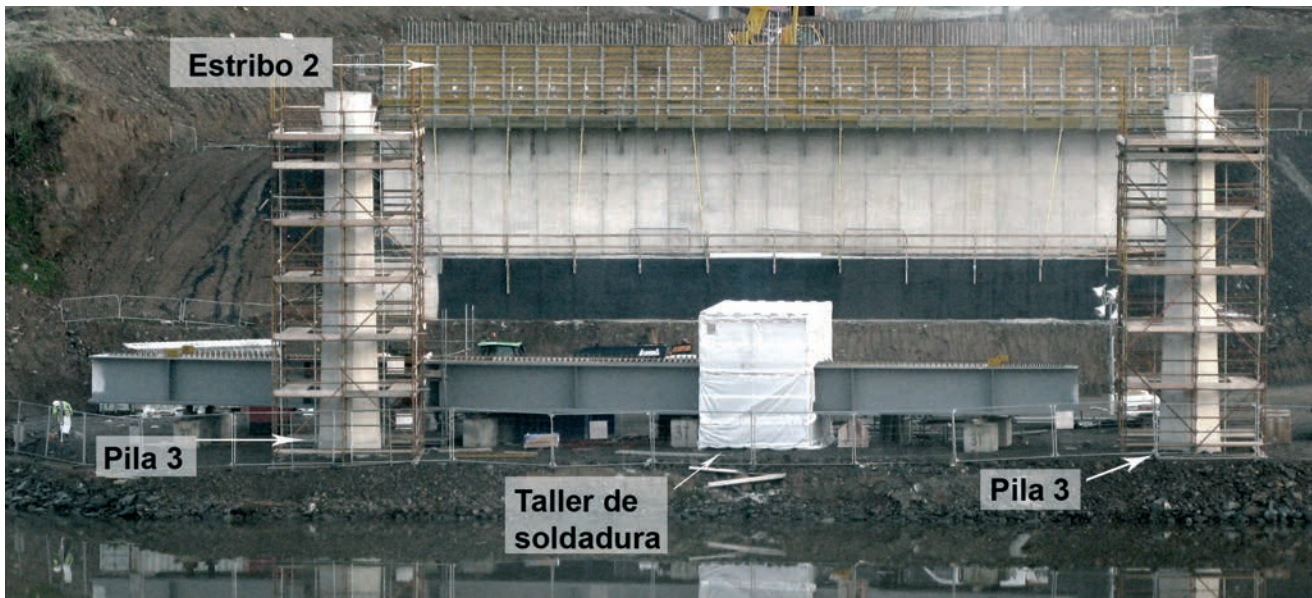
Figura 18. Soldadura en obra de tramos de vigas longitudinales
Figure 18. On site edge girder segments welding

ing created many difficulties because of the very strict conditions which have to be met; welding took place over the embankment close to abutment E2 (Figure 18) and

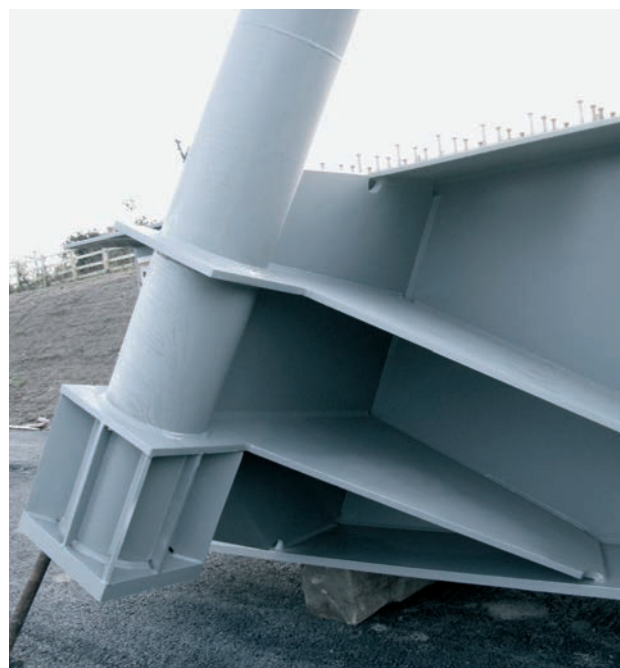
Figura 20. Anclaje de un tirante en el tablero
Figure 20. Deck anchorage of a cable

Para anclar los cables contra una prolongación de las almas de las vigas longitudinales hubiera sido necesario aumentar inútilmente la anchura del puente en toda su longitud. Por ello se optó por la solución de anclar los cables contra unas estructuras metálicas que vuelan por fuera de las vigas longitudinales de borde y tapar dichos anclajes con la imposta. La

estructura de soporte del anclaje consiste en un tubo estructural que recibe la carga de la placa de anclaje y la transmite al tablero mediante una chapa soldada a una de las generatrices del tubo y al alma y alas de la viga longitudinal de borde (Figura 20). Esta chapa se rigidiza con dos placas transversales que se sueldan también al tubo para transmitir al tablero las cargas transversales (fundamentalmente de viento) impuestas por el cable. La fabricación de estos anclajes exigió un trabajo muy fino de replanteo (esta estructura define el ángulo de salida del tirante) y control de soldaduras y en el proyecto hubo que recurrir a modelos de elementos finitos como el que se muestra en la Figura 21. En esta figura se puede

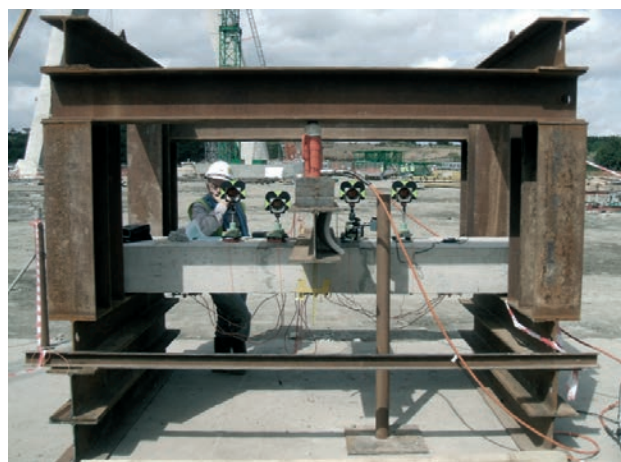
Figura 25. Ensayo de flexión en tres puntos de una junta de tablero
 Figure 25. Three point bending test of a deck slab joint

Since this solution could not be checked by following the clauses of British Standards, neither in service nor in ultimate state, and, although there is some research work available about such kind of joints [8-10], it became necessary to test two of these joints to validate the design. The tests were carried out on two specimens of the slab which were subjected to a three point bending state of stress (Figure 25), which was considered representative of the actual state of stress in the joints. Interesting conclusions could be derived from these tests, for service as well as for ultimate states. At rupture, it was verified that the capacity of the joint is not less than that of a concrete slab with the same amount of reinforcement; then it was shown that the anchorage and overlapping of the loop bars was sufficient. The limit value of the load which was measured in the tests (Figure 26, where the initiation of cracking and rebar yielding have been marked) was almost coincident with the value which could be obtained by applying the

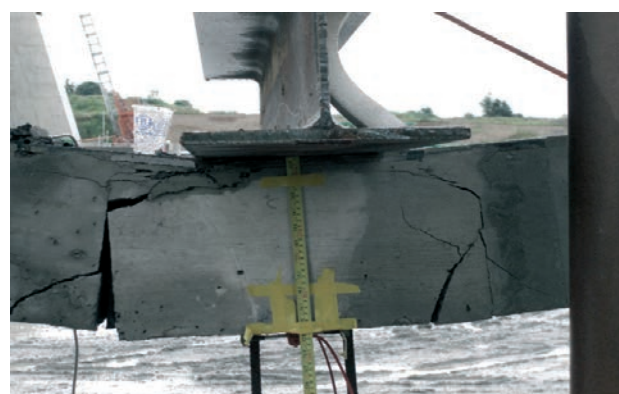
Figura 27. Junta entre losas prefabricadas después del ensayo.
 Figure 27. Joint between precast slabs after the test.

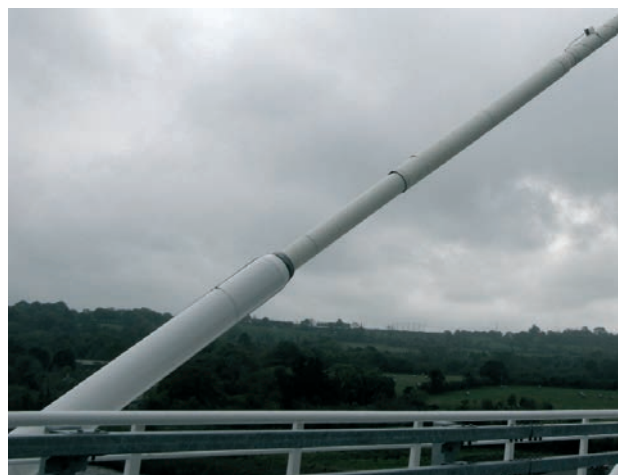
Figura 30. Tubo antivandálico y acelerómetro colocado en un tirante
Figure 30. Anti-vandalism tube and accelerometer installed on a cable

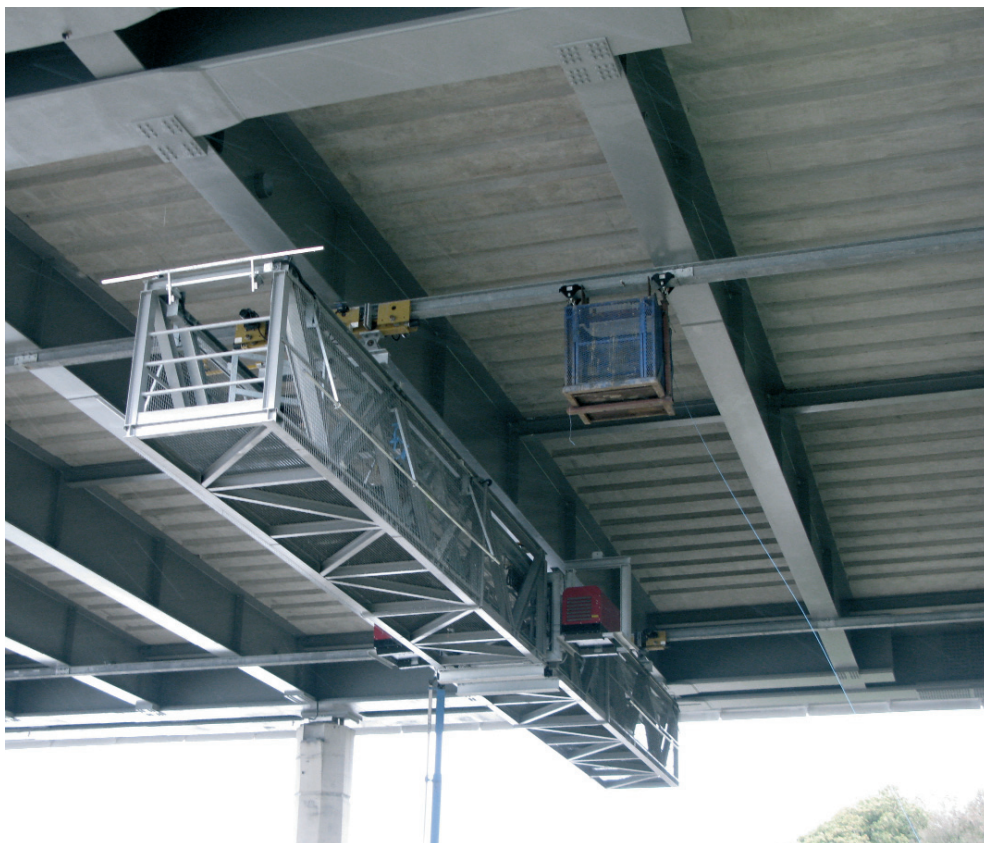
Figura 35. Carro de mantenimiento
Figure 35. Maintenance gantry

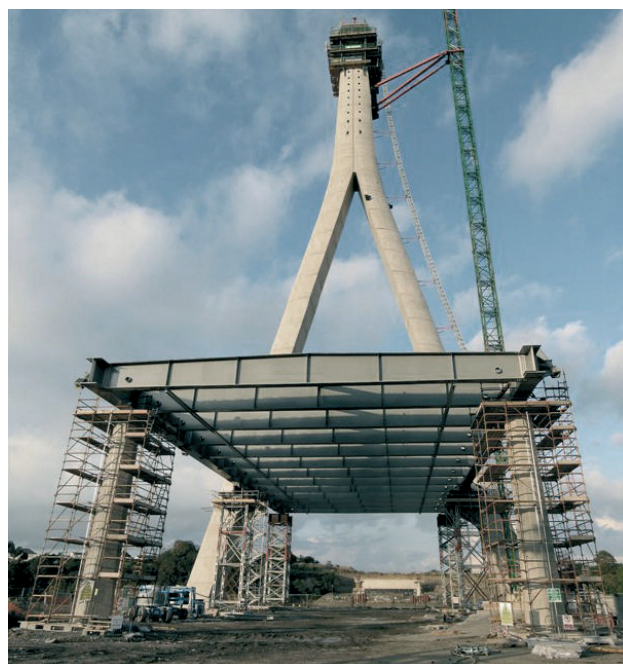
Figura 36. Montaje de estructura metálica en vanos traseros.
Figure 36. Installation of steel structure in back spans.
