El puente atirantado sobre el río Suir en Waterford

Cable-stayed bridge across the River Suir at Waterford

Miguel A. Astiz⁽¹⁾, Javier Manterola⁽¹⁾, Felipe Tarquis⁽²⁾, Javier Muñoz-Rojas⁽³⁾, Antonio Santos⁽⁴⁾,
Lucía Blanco⁽³⁾ y Sara Fernández⁽³⁾

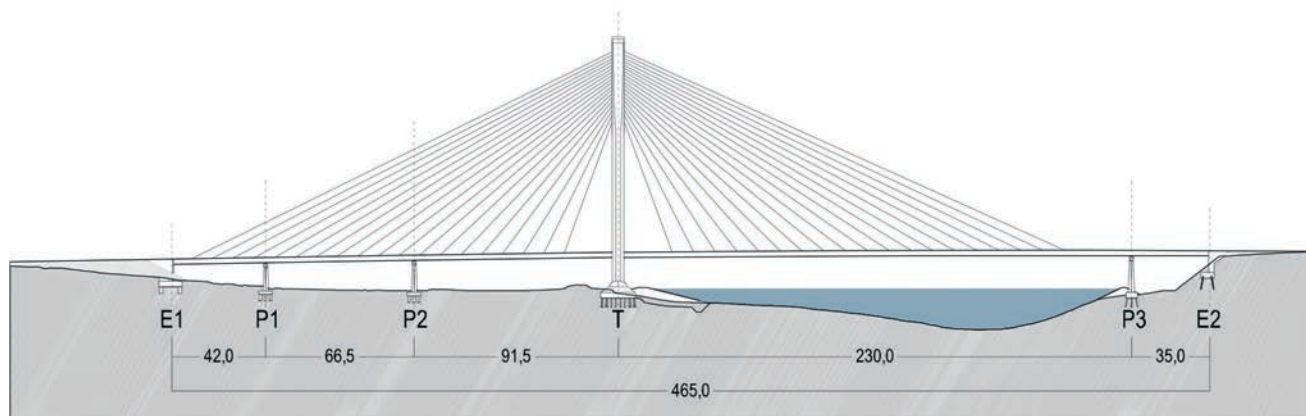
Figura 1. Alzado general del puente
Figure 1. General elevation of the bridge

As a consequence of the topographic conditions, the resulting bridge has a single pylon, which is located on the flat river bank and three cable stayed spans have been designed on this side (Figure 1) while on the opposite bank the bridge has a single approach span. Total length of the bridge is 465 m and the main span is 230 m long. The span length distribution is: 42.0 + 66.5 + 91.5 + 230.0 + 35.0 m.

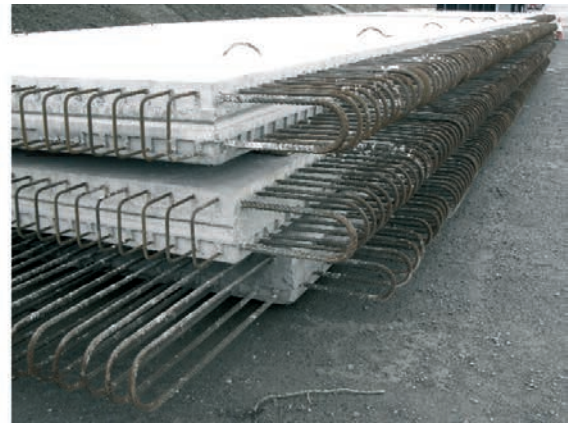
Figura 24. Junta transversal en el tablero y lazos de armadura de conexión
 Figure 24. Transverse joint in the deck and connecting rebar loops

The most controversial detail of this solution may be found in the transverse stitches. In these joints it is necessary to provide continuity for the longitudinal rebars (especially for the top layer because of hogging moments over the cross beams). The classical solution consists in providing loop bars, in both slabs being connected, which overlap (although over a length which is less than the minimum to secure the full transmission of forces from one bar to the other); the opposite loops create a central compressed nucleus in the joint where both bars are safely anchored (Figure 24). This is a problem which has appeared in other bridges with a composite deck, such as the Ting-Kau bridge in Hong-Kong or the river Cooper bridge in Charleston, and it has been solved in a similar way.

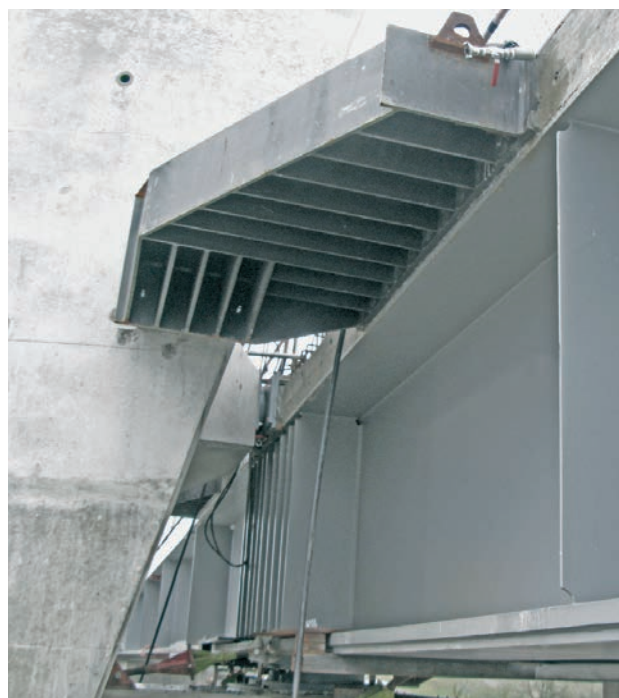
Figura 28. Tope de bloqueo del tablero en la torre
Figure 28. Corbel to block the deck movement at the pylon

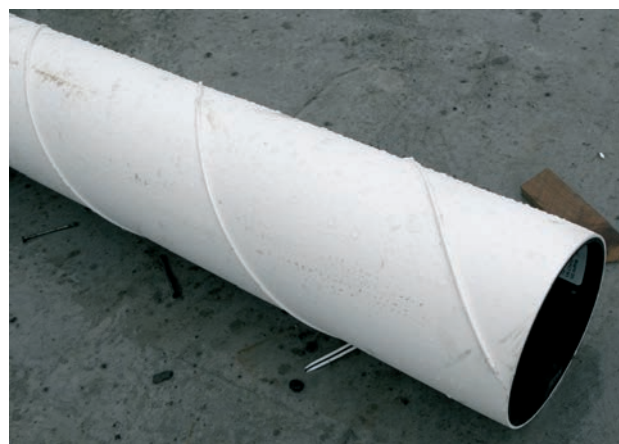
Figura 29. Vaina exterior de los tirantes
Figure 29. External sheath of the cables

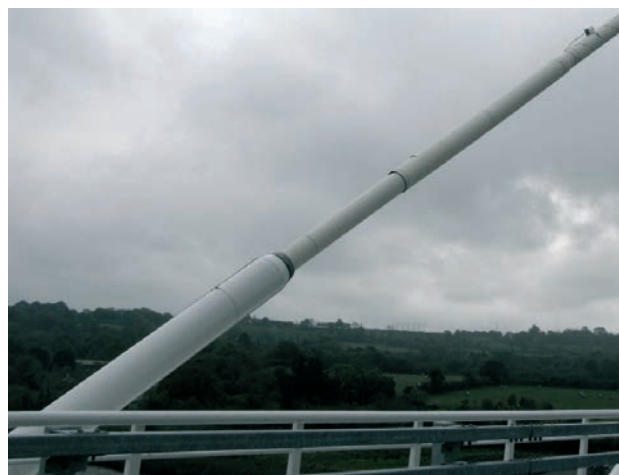
Figura 30. Tubo antivandálico y acelerómetro colocado en un tirante
Figure 30. Anti-vandalism tube and accelerometer installed on a cable

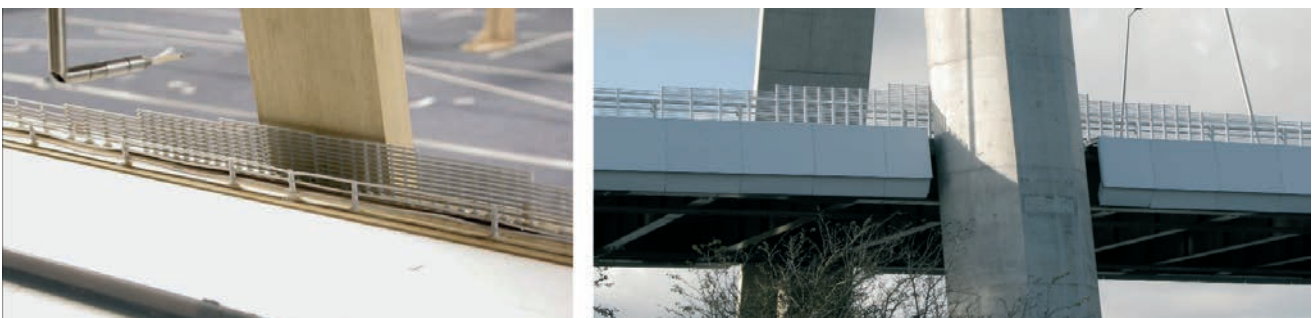
Figura 32. Barandilla alrededor de la torre (modelo y prototipo)
Figure 32. Pedestrian guardrail in the neighbourhood of the pylon (model and prototype)

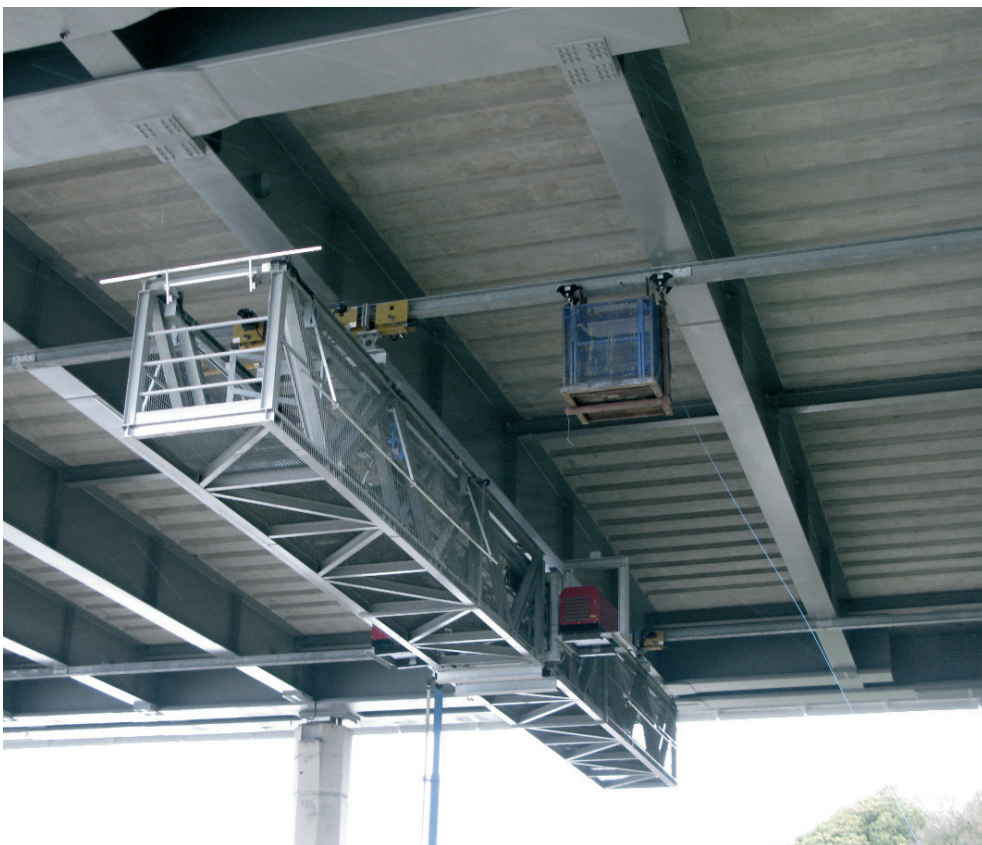
Figura 35. Carro de mantenimiento
Figure 35. Maintenance gantry

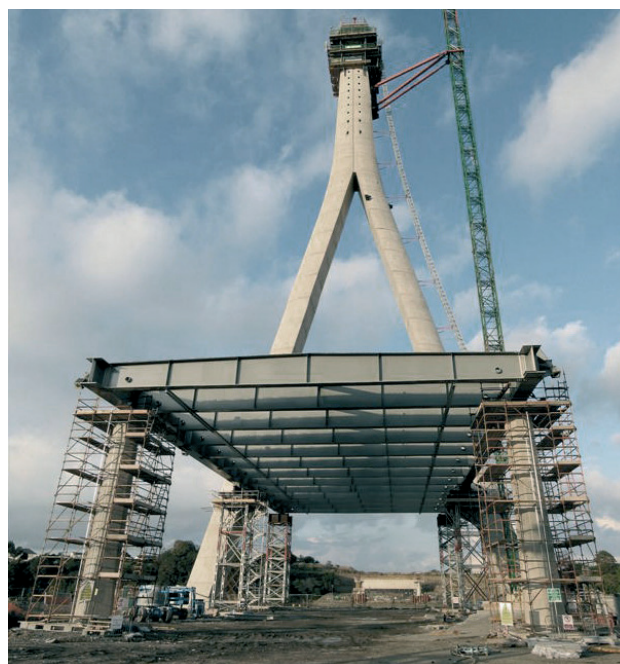
Figura 36. Montaje de estructura metálica en vanos traseros.
Figure 36. Installation of steel structure in back spans.

relative to construction is the deck. The steel structure was fabricated in Chepstow (Wales) and it was transported first by ship and then by road to the site. The edge girders (including the cable anchorages) came in 10 m long segments and the cross beams came complete. The back

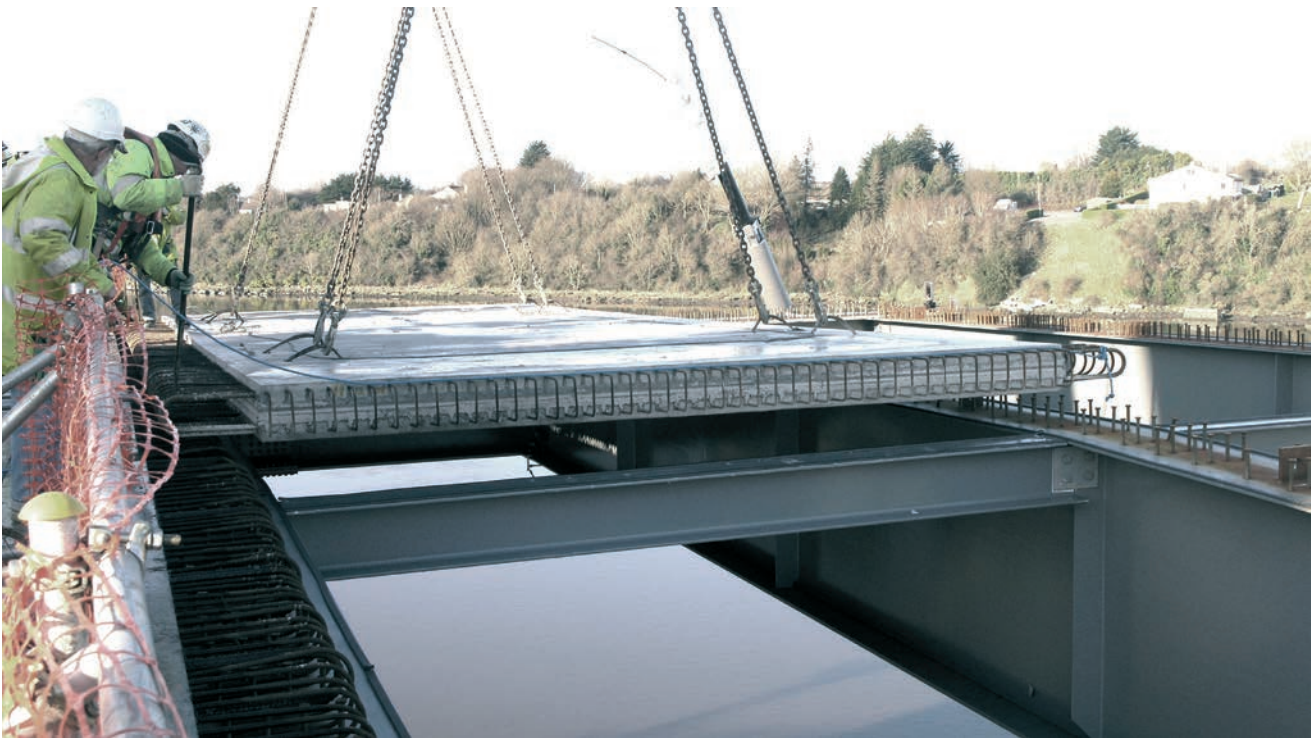
Figura 38. Colocación de losas prefabricadas
Figure 38. Installation of precast slabs

- Installation of edge girders
- Installation of cross beams
- Installation of concrete slabs
- Installation of reinforcement in the stitches
- Concrete casting of the stitches and edge bands
- Stressing the cables

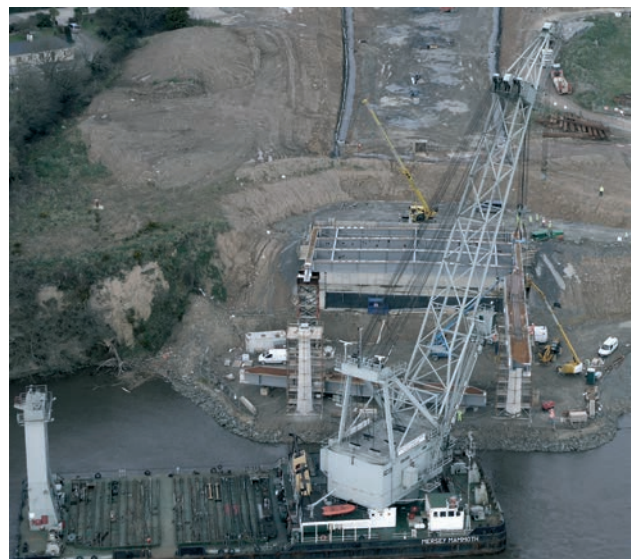
Figura 39. Colocación del tramo de espera mediante grúa flotante
Figure 39. Installation of the end span by a floating crane

El montaje del vano de espera en el extremo Norte del puente (estribo E2) fue especialmente complicado, debido al peso de las vigas de borde, unas 160 t (en esa zona son dobles y tienen una longitud de 36
