El puente atirantado sobre el río Suir en Waterford

Cable-stayed bridge across the River Suir at Waterford

Miguel A. Astiz⁽¹⁾, Javier Manterola⁽¹⁾, Felipe Tarquis⁽²⁾, Javier Muñoz-Rojas⁽³⁾, Antonio Santos⁽⁴⁾,
 Lucía Blanco⁽³⁾ y Sara Fernández⁽³⁾

The bridge across the river Suir at Waterford (Ireland) is a cable-stayed bridge with 465 m total length, a 230 m long main span and a single pylon. This bridge has a number of characteristics which make it singular: the use of high capacity micropiles in the foundations, an inverted Y-shaped pylon without any transverse beam at deck's level, the anchorage of the cables at the pylon by means of an internal steel structure, its composite deck which consists of a steel ladder shaped structure with two or four edge beams and cross beams and of precast ribbed concrete slabs, the variable width of the deck or the fact that there is only one expansion joint at one of the abutments, since the bridge is integral with the other abutment.

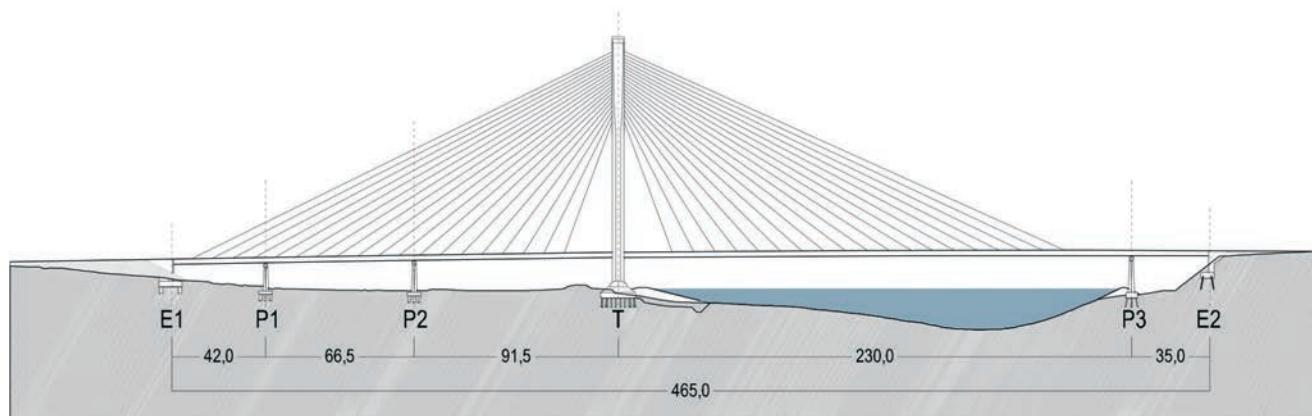
Figura 1. Alzado general del puente
Figure 1. General elevation of the bridge

As a consequence of the topographic conditions, the resulting bridge has a single pylon, which is located on the flat river bank and three cable stayed spans have been designed on this side (Figure 1) while on the opposite bank the bridge has a single approach span. Total length of the bridge is 465 m and the main span is 230 m long. The span length distribution is: 42.0 + 66.5 + 91.5 + 230.0 + 35.0 m.

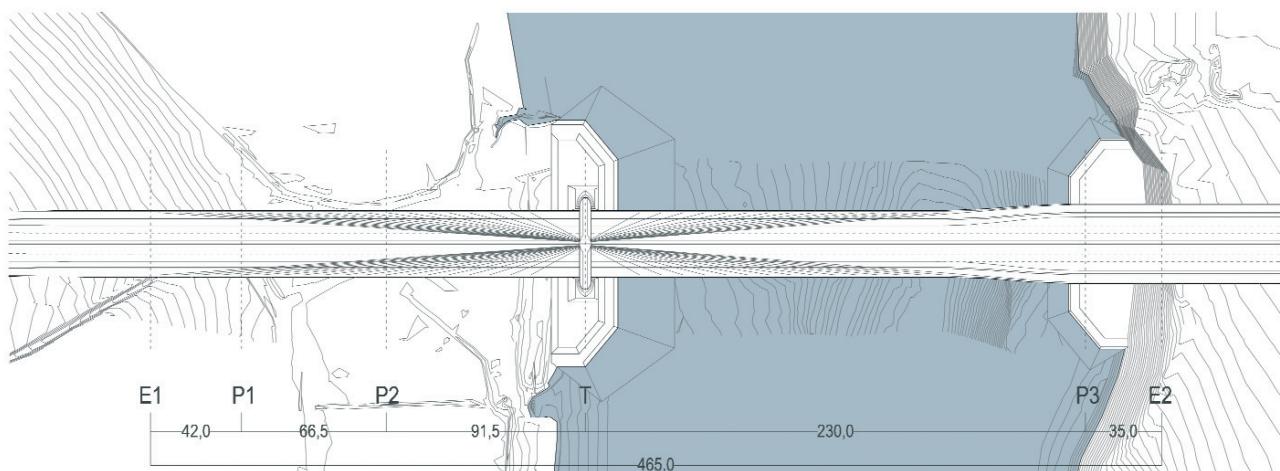
Figura 2. Planta general del puente
Figure 2. Plan view of the bridge

La variación de anchura llega a afectar a la parte del puente que está atirantada (Figura 2), lo que obligó a realizar una serie de estudios sobre la base de imágenes fotorrealistas tri-dimensionales del puente, para minimizar el impacto estético que esta inusual configuración de anchura variable pudiera tener. Es de destacar el importante papel que han jugado dichas imágenes en la definición de muchos aspectos formales del puente, ya que han representado la principal base de argumentación en las discusiones con la Administración. Así, por ejemplo, el proyecto base del puente mostraba una concentración de

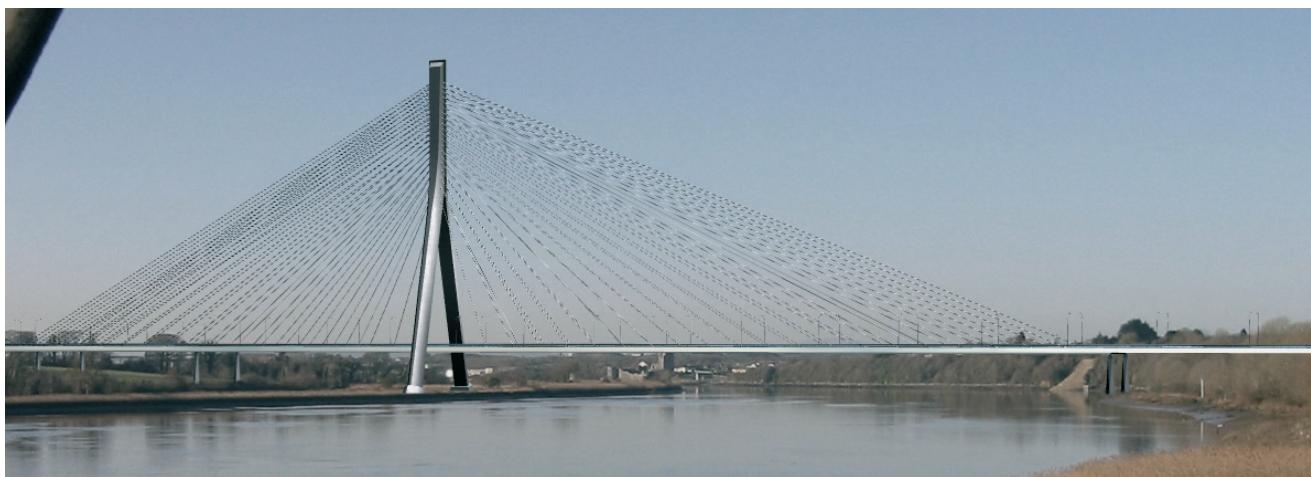
Figura 3. Imagen fotorrealista de la propuesta de concurso.

Figure 3. Photorealistic image of the bidding proposal.

cables cercanos al estribo trasero (E1), porque es una forma eficaz de sujetar la torre y así se planteó, aunque algo suavizada, la propuesta que se presentó en el concurso tal como se aprecia en la Figura 3. En la solución finalmente construida, la distribución de anclajes de cables en el tablero se ha hecho uniforme como se aprecia en la Figura 1. Éste es un primer ejemplo de las mejoras estéticas que se pueden conseguir a través de actuaciones sobre la estructura.

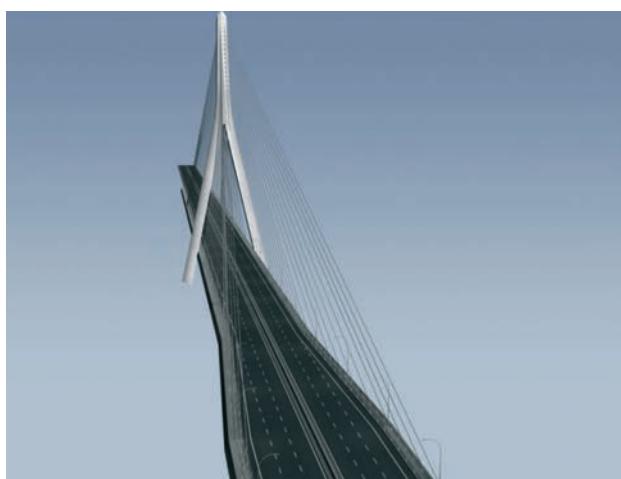
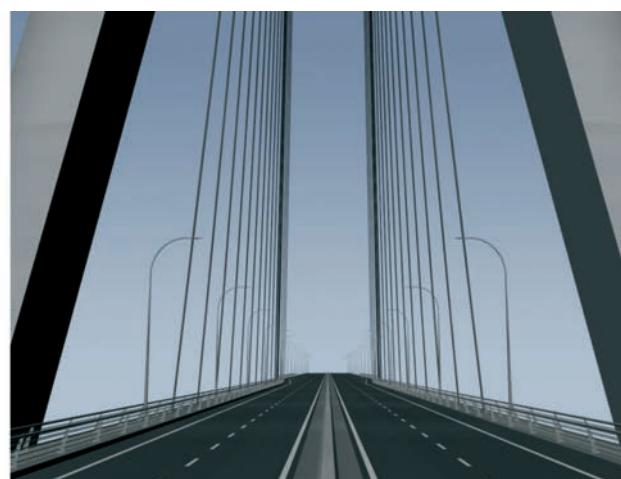
Figura 4. Imágenes de los tirantes en su versión primitiva.

Figure 4. Images of the cable stays in their primitive version

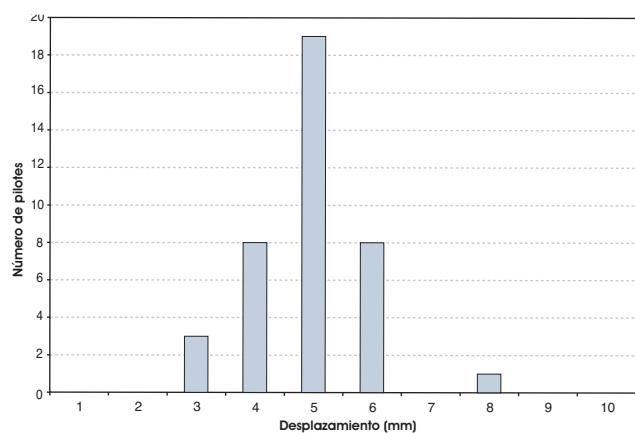
Figura 5. Distribución de desplazamientos en cabeza de pilotes para una carga de 2.000 kN

Figure 5. Distribution of pile head displacements for a load of 2 000 kN.

La carga de proyecto de los micropilotes se estimó en 5.000 kN y la de agotamiento en unos 12.500 kN. Como forma de validación del concepto de micropilote propuesto y por un requisito previo del pliego de condiciones, se llevaron a cabo tres ensayos in situ a compresión, hasta la supuesta carga de rotura, sobre tres pilotes de prueba, cuya longitud de empotramiento en roca era algo más de la mitad de la proyectada y que, por lo tanto, deberían tener una carga de agotamiento superior a la mitad de la proyectada. Esta limitación de la longitud de los micropilotes ensayados permite limitar el valor de la fuerza a aplicar, pero también reduce la influencia del ensayo sobre los pilotes circundantes, que son definitivos y se utilizan también en el ensayo. En la punta de estos micropilotes se instaló una almohadilla para anular la carga de transmisión por punta. La carga del ensayo de compresión se aplicó contra una estructura metálica que se equilibraba tirando de 4 pilotes definitivos, con una carga de tracción igual a la cuarta parte de la carga de ensayo, lo cual también representaba un ensayo fiable de los cuatro pilotes a una carga similar a la carga de trabajo de estos pilotes. La carga última del ensayo fue de 8.300 kN (netamente superior por lo tanto a la carga de proyecto) y el comportamiento del pilote fue prácticamente lineal durante todo el ensayo. En estos ensayos se dispusie-

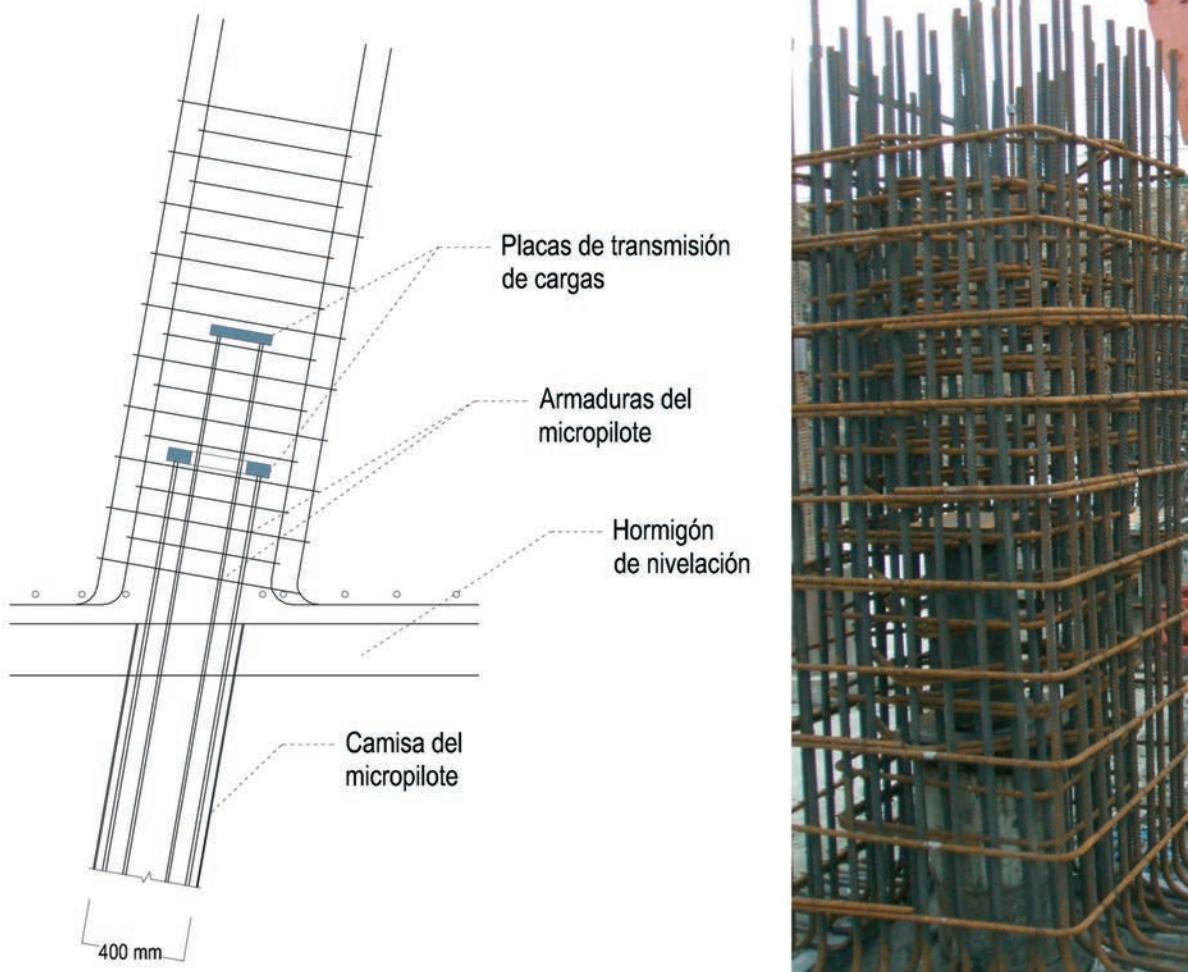
Figura 6. Armadura de refuerzo alrededor de las cabezas de los micropilotes
Figura 6. Reinforcing cage around the micropile head.

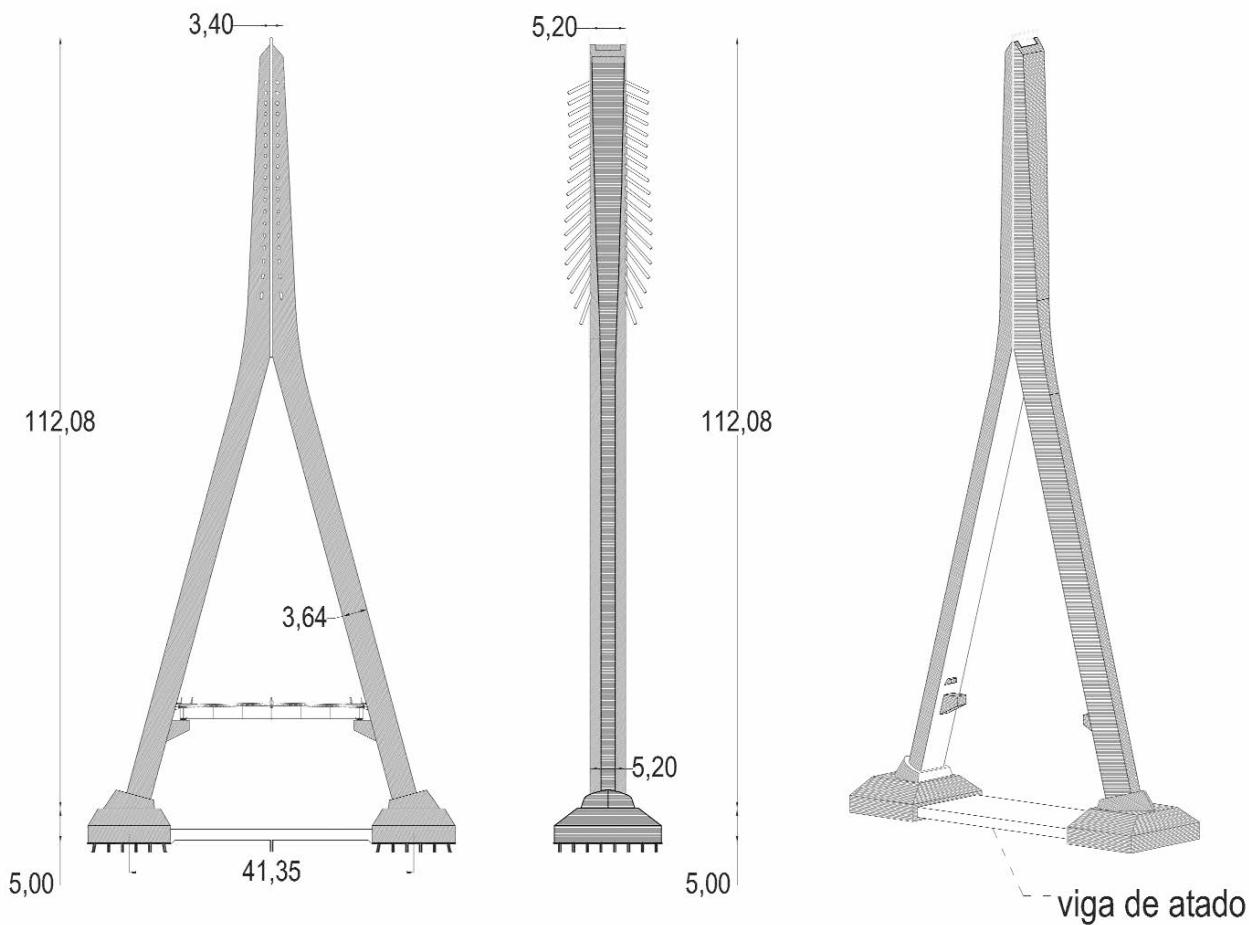
Figura 7. Alzados de la torre
Figure 7. Elevations of the pylon

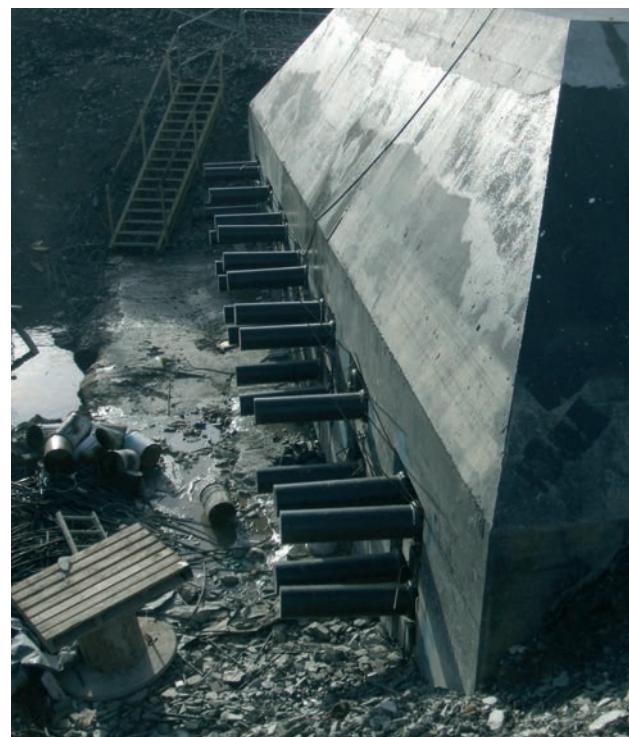
Figura 8. Anclajes del pretensado de la viga de atado
Figure 8. Anchorages for the tie beam prestressing

Dada la prevención existente en el mundo anglosajón contra el pretensado interior, se dispuso un pretensado no adherente con vainas de polietileno e inyección de cera. Los cables de pretensado se aislaron eléctricamente de las placas de anclaje y se dejó prevista la posibilidad de sustitución de cualquier cordón durante una inspección posterior, en caso de que se llegara a detectar algún movimiento en los encepados de la torre. Además se dejaron instaladas cuatro vainas adicionales (vacías y selladas), para tener la posibili-

Because of the caution existing in British engineering community against interior prestressing, prestressing was designed as non adherent with wax filled polyethylene sheaths. The cables were electrically isolated from the anchorage plates and the possibility was left for the substitution of any strand in the future if, during an inspection, some movement of the foundations is detected. In addition, four more sheaths were installed (empty and sealed) to let the possibility of adding four more prestressing cables to the tie beam. The inspection of the tie beam is performed by means of 16 vibrating wire extensometers whose data are recorded in a continuous manner. If the foreseen values were surpassed at any time, an alarm would be generated to inform the bridge operator who would ask for correcting steps.

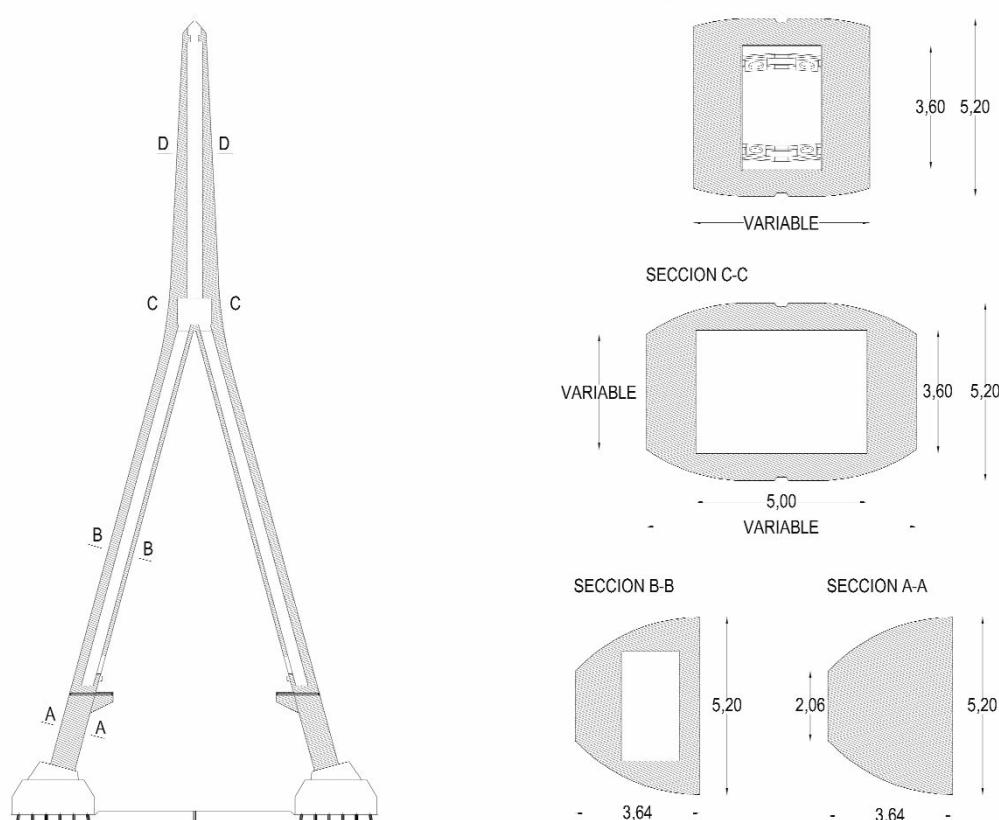
Figura 9. Secciones de la torre.
Figure 9. Cross sections of the pylon

La sección transversal de las patas de la torre se ha proyectado de forma que se combine su eficacia contra las acciones del viento (reducción de las acciones y rigidez a flexión), con los aspectos estéticos, tratando de hacerla lo más esbelta posible. Consiste en la intersección de dos cilindros circulares y dos planos. La unión de las patas y su prolongación en el mástil se lleva a cabo mediante una transición circular que se ha hecho tan corta como ha sido posible, para facilitar la construcción sin perjudicar a la estética (en las trepas correspondientes a esta transición, resultaba necesario bajar los encofrados para ajustarlos, cosa que no era necesaria en el mástil). El mástil es de sección variable, ya que se va reduciendo su anchura en el sentido transversal al eje del puente conforme aumenta la altura. Las dimensiones más características son la altura total, 112 m sobre el encepado, y la anchura de las patas en la dirección del puente, 5,2 m (Figura 9). Por el hueco de una de las patas y del mástil se llevan sendos ascensores para facilitar las labores de inspección y mantenimiento. El tramo de patas situado por debajo del tablero se

proyectó inicialmente hueco, pero acabó macizándose por varias razones: mayor rigidez y resistencia frente al posible choque de barcos, mayor robustez en la sección de apoyo del tablero y menores problemas de inspección y mantenimiento.

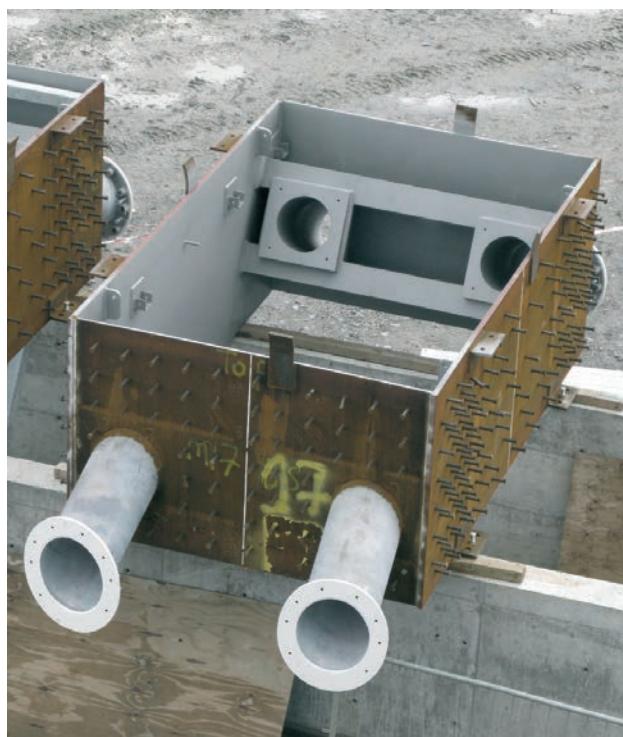
Figura 10. Cajón de anclaje de tirantes en torre
Figure 10. Anchorage box for the pylon

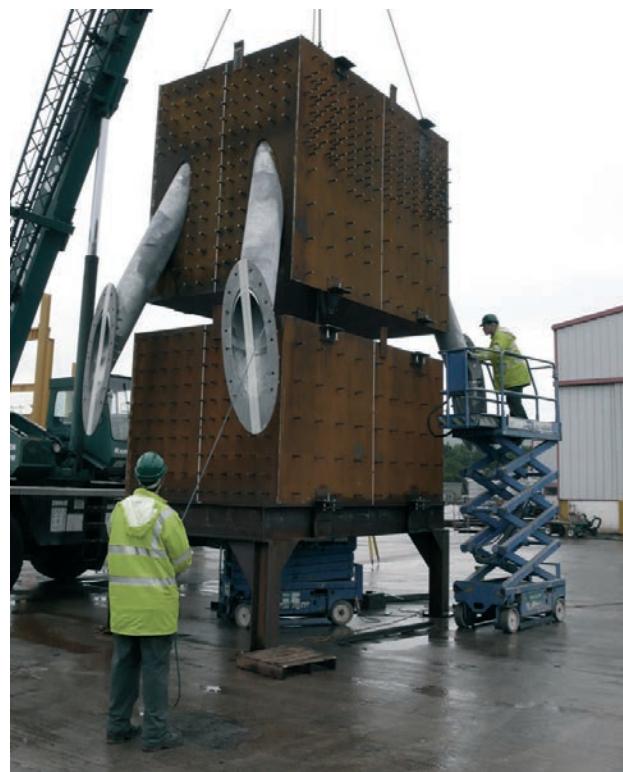
Figura 11. Montaje en blanco de cajones en taller
Figure 11. Trial assembly of the boxes at workshop

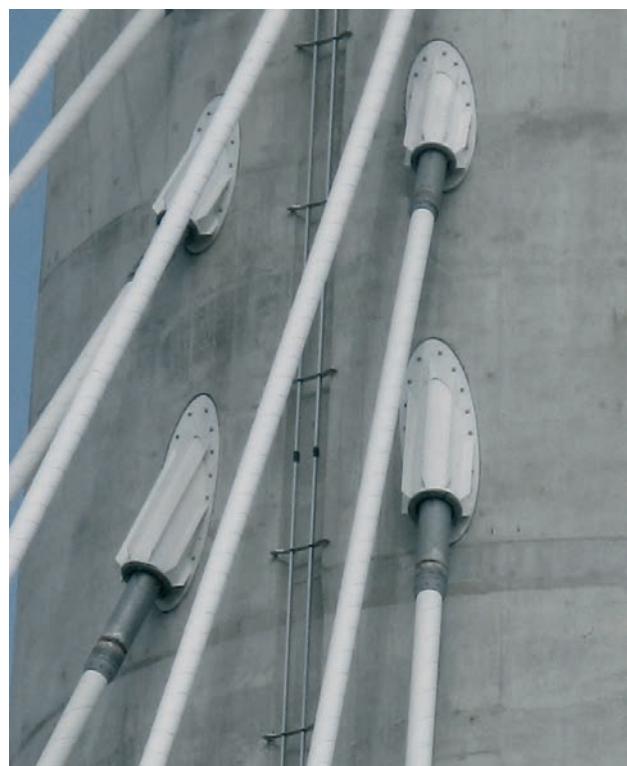
Figura 12. Tubos de tirantes en el exterior de la torre
Figure 12. Cable tubes outside the pylon

Los cajones llevan incorporado el tubo por el que se introduce el tirante, que no tiene misión estructural, sino sólo de encofrado. Estos tubos se rematan mediante una chapa elíptica, de tal forma que el conjunto quede en el interior del encofrado de la torre. De esta manera no es necesario perforar el encofrado y las operaciones de hormigonado de la torre se facilitan notablemente. Una vez construida la torre, los tubos se prolongan mediante otros tubos también rematados con una chapa elíptica gemela de la anterior, que se atornilla a ésta (Figura 12). La longitud de los tubos exteriores es la necesaria para contener el centrador del tirante. Estos tubos llevan unos rigidizadores radiales para reducir los problemas de fatiga producidos por las acciones de viento sobre los tirantes. Con el mismo fin de no alterar los encofrados, las ménsulas de apoyo del tablero se

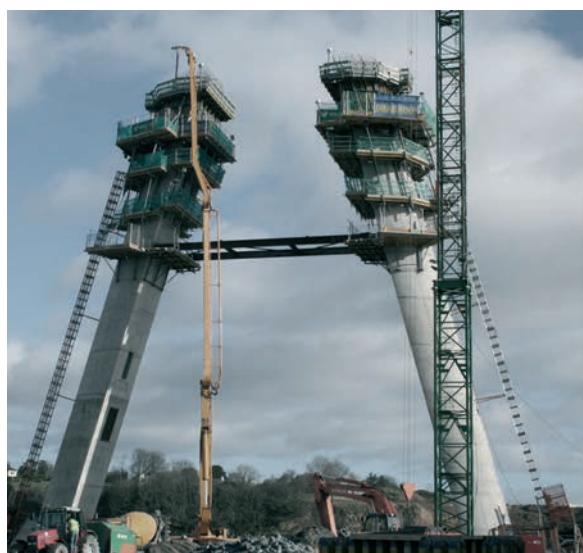
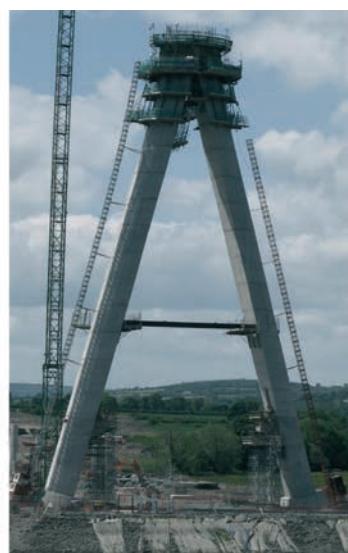
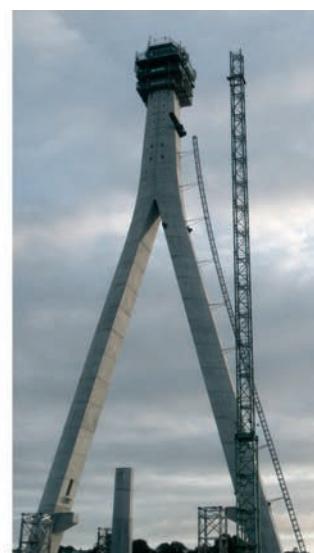
Figura 13. Distintas fases de construcción de la torre
Figure 13. Different stages in the construction of the pylon

La construcción de la torre se realizó mediante encofrado trepador en trepas de 4 m. Aunque la superficie exterior es curva, dado que el perfil curvo de la sección transversal se mantiene constante, sólo resultó necesario desmontar los encofrados en la zona de transición de patas a mástil, de directriz también curva, como se ha indicado anteriormente. La inclinación de las patas obligó a apuntalar una contra la otra mediante dos puntales horizontales, para limitar las flexiones en dichas patas (Figura 13). Uno de los puntales se situó a media altura y el otro en la intersección entre las patas.

Ambos puntales iban equipados con gatos que permitían ajustar la deformada y la ley de esfuerzos a los óptimos definidos en proyecto. Una vez que se produjo la unión de las patas, la construcción del mástil vertical se realizó sin recurrir a ningún sistema de sujeción adicional. Se dispuso una grúa torre que se arrostró contra la propia torre del puente.

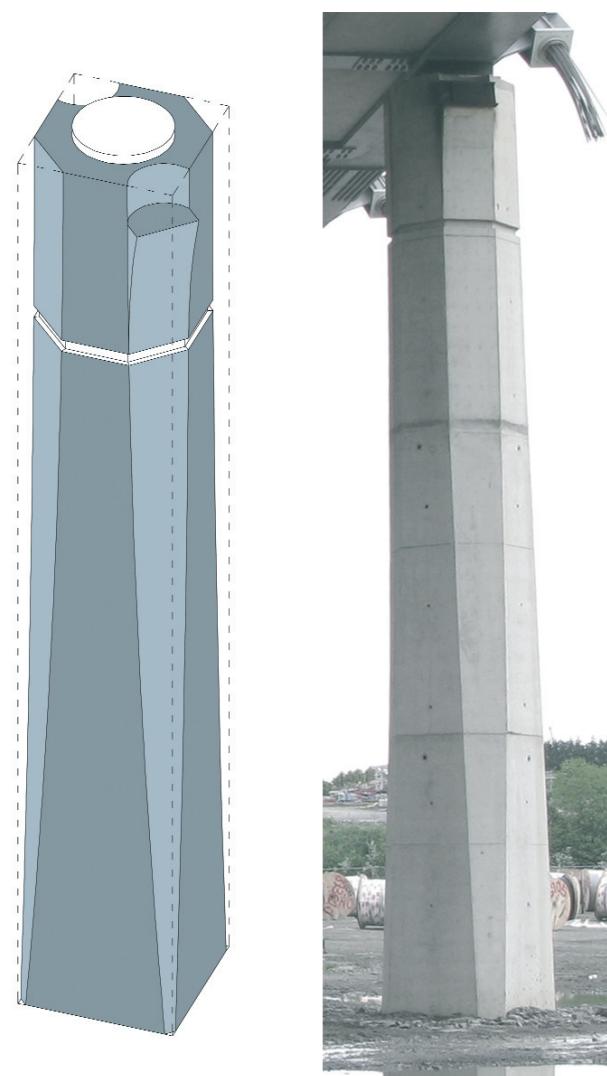
Figura 14. Perspectiva y foto de una pila
Figure 14. Perspective view and photo of one pier

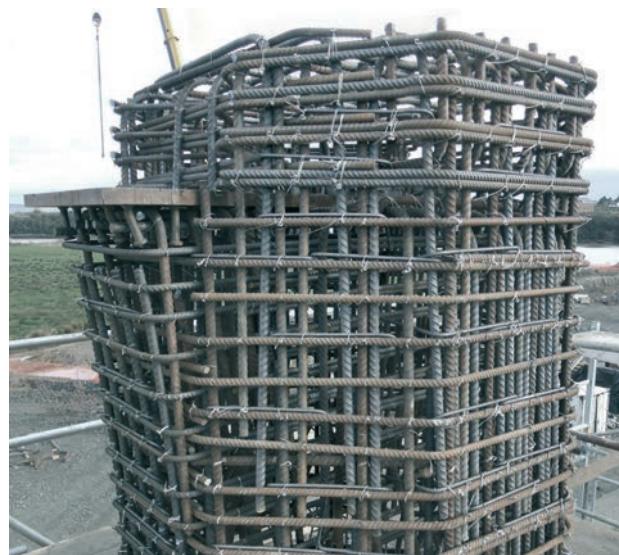
Figura 15. Armado de la cabeza de una pila
Figure 15. Reinforcement of one pier

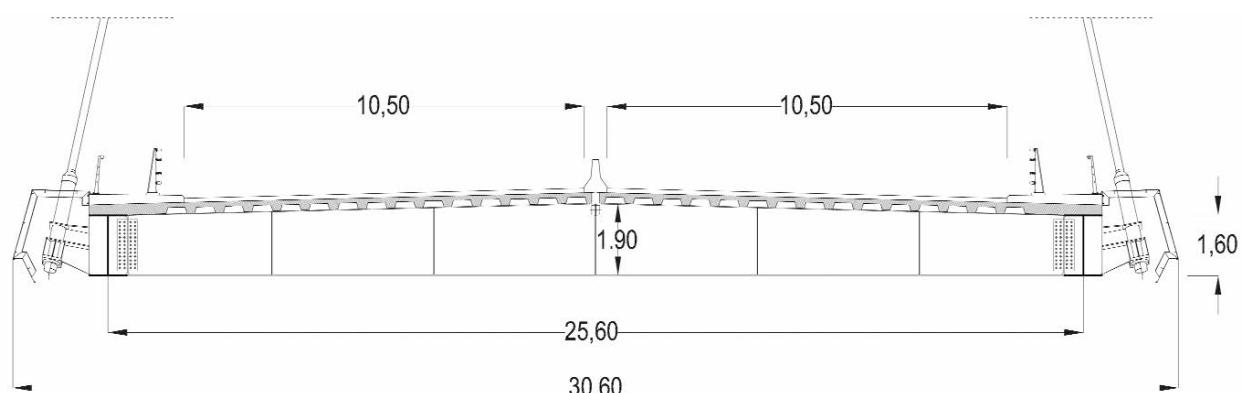
Figura 16. Sección transversal del tablero
Figure 16. Deck cross section

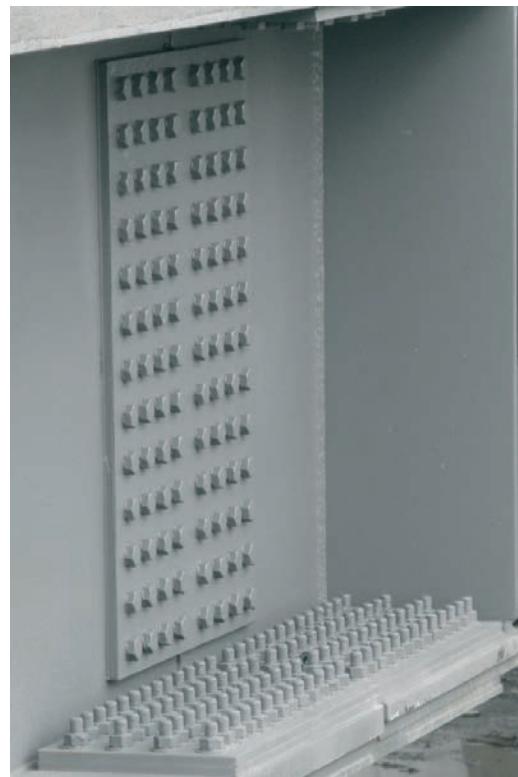
Figura 17. Unión atornillada en viga de borde longitudinal
Figure 17. Bolted connection in an edge girder

Esta estructura metálica se construyó íntegramente en taller, en tramos no mayores de 20 m para las vigas longitudinales. Las vigas transversales se construyeron completas. Todas las estructuras montadas en taller van soldadas, mientras que casi todas las uniones realizadas en obra son atornilladas, mediante tornillos de alta resistencia (Figura 17). Sólo algu-

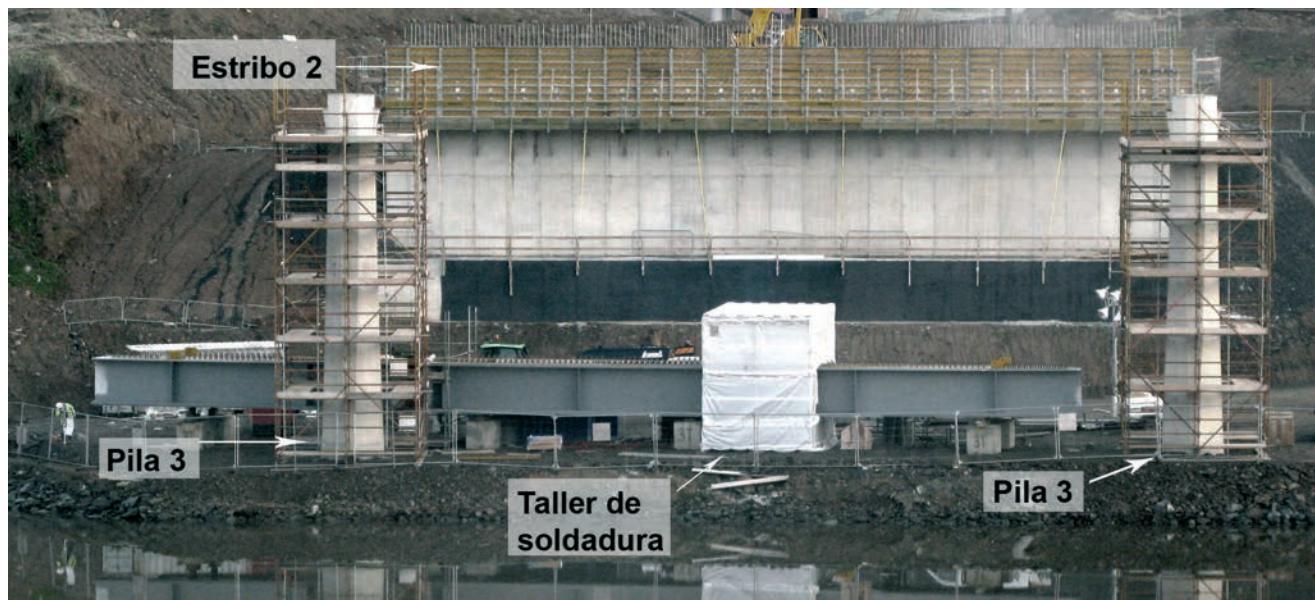
Figura 18. Soldadura en obra de tramos de vigas longitudinales
Figure 18. On site edge girder segments welding

ing created many difficulties because of the very strict conditions which have to be met; welding took place over the embankment close to abutment E2 (Figure 18) and

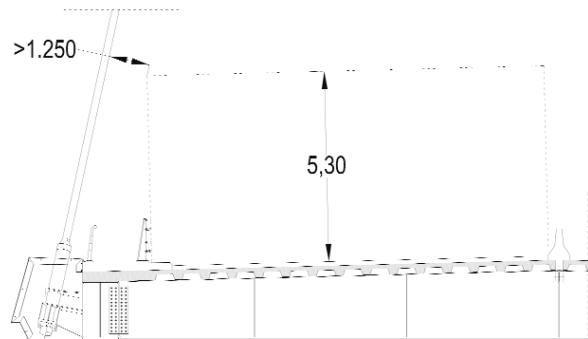
Figura 19. Condición de separación de tirantes respecto al tráfico
Figure 19. Clearance condition for the cables with respect to traffic

The most complicated problem to be solved on the deck has been the connection to the cable anchorages. For a steel or composite deck with edge girders, the simplest solution would consist in locating the anchorages above the deck and connecting them to an extension of the web of each girder. But in this case, two preliminary conditions, which were set by the Administration, made this alternative impossible: the anchorages had to be hidden for aesthetical reasons and the minimum clearance between the cables and the traffic envelope had to be 1.25 m (Figure 19). This traffic envelope is defined from the position of the traffic barriers. Although the need to hide the anchorages may be questionable since it is a matter of aesthetics, the clearance condition is very reasonable to keep the cables far enough from traffic thus avoiding the impact of a vehicle against the cables.

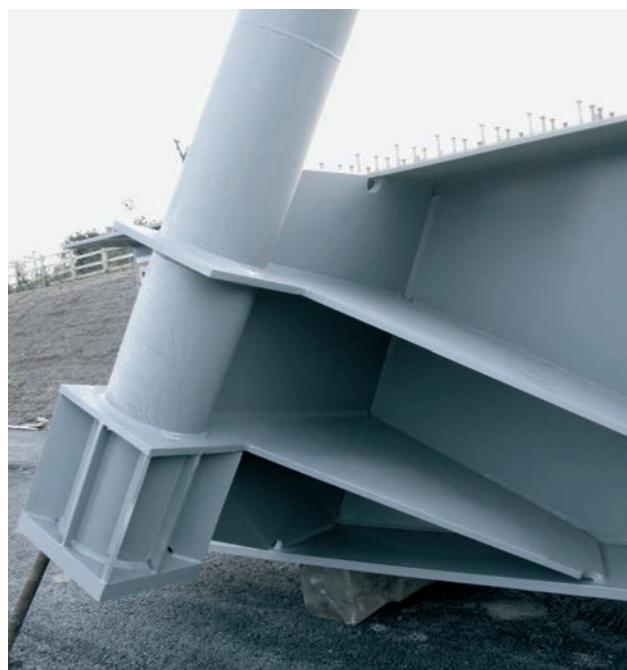
Figura 20. Anclaje de un tirante en el tablero
Figure 20. Deck anchorage of a cable

Para anclar los cables contra una prolongación de las almas de las vigas longitudinales hubiera sido necesario aumentar inútilmente la anchura del puente en toda su longitud. Por ello se optó por la solución de anclar los cables contra unas estructuras metálicas que vuelan por fuera de las vigas longitudinales de borde y tapar dichos anclajes con la imposta. La

estructura de soporte del anclaje consiste en un tubo estructural que recibe la carga de la placa de anclaje y la transmite al tablero mediante una chapa soldada a una de las generatrices del tubo y al alma y alas de la viga longitudinal de borde (Figura 20). Esta chapa se rigidiza con dos placas transversales que se sujetan también al tubo para transmitir al tablero las cargas transversales (fundamentalmente de viento) impuestas por el cable. La fabricación de estos anclajes exigió un trabajo muy fino de replanteo (esta estructura define el ángulo de salida del tirante) y control de soldaduras y en el proyecto hubo que recurrir a modelos de elementos finitos como el que se muestra en la Figura 21. En esta figura se puede

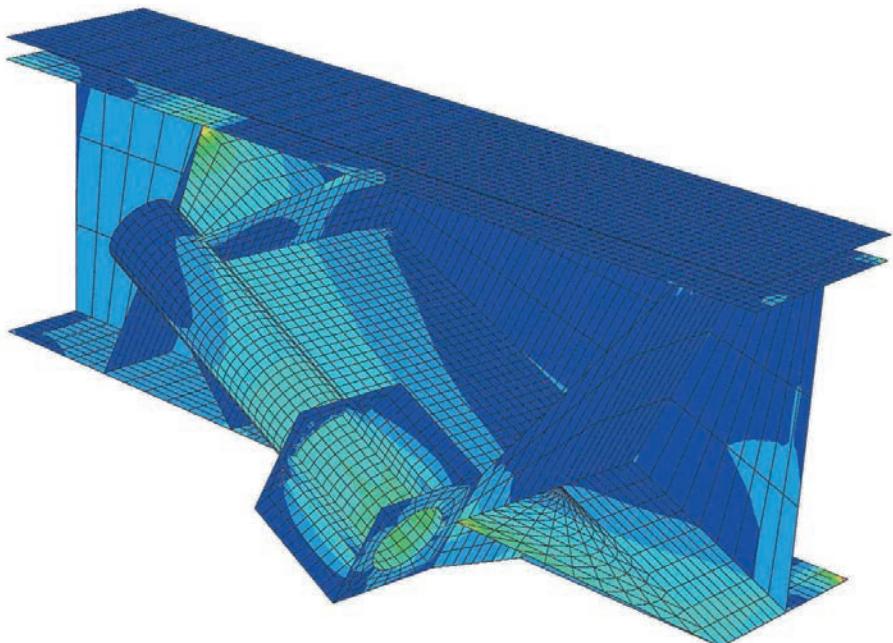
Figura 21. Distribución de tensiones de von Mises en anclaje de tirante al tablero
Figure 21. von Mises stress distribution in a deck anchorage

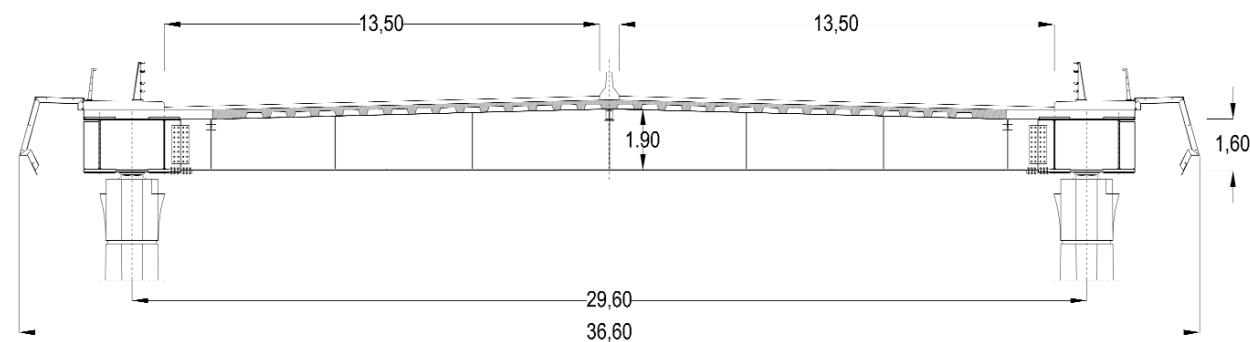
Figura 22. Sección transversal del tablero sobre las pilas P3
Figure 22. Deck cross section over piers P3.

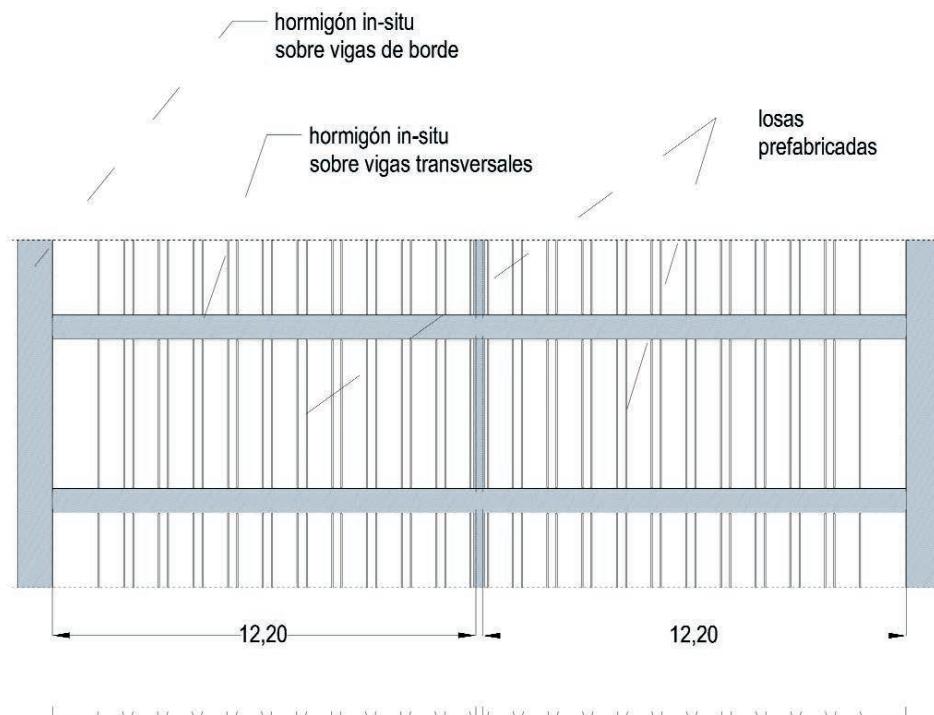
Figura 23. Losas prefabricadas (planta y sección)
Figure 23. Precast slabs (plan view and cross section)

The consideration of all these factors led to choosing a solution based on a precast ribbed reinforced concrete slab with a total depth of 0.28 m and a mean equivalent thickness of 0.20 m. The width of the bridge is covered with two 12.20 m wide slabs while the area above the edge girders is solid and it is cast in place (Figure 23). Precast slabs are supported on cross beams, one of the edge girders and a longitudinal beam which is located along the bridge axis and whose sole function consists in supporting the weight of the slabs before casting the joints.

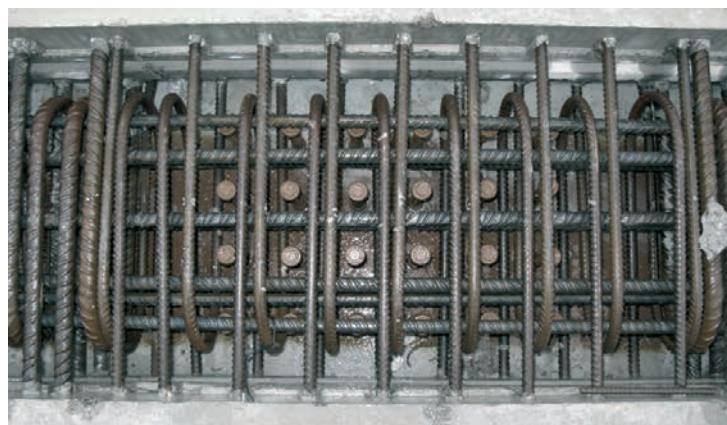
Figura 24. Junta transversal en el tablero y lazos de armadura de conexión
Figure 24. Transverse joint in the deck and connecting rebar loops

The most controversial detail of this solution may be found in the transverse stitches. In these joints it is necessary to provide continuity for the longitudinal rebars (especially for the top layer because of hogging moments over the cross beams). The classical solution consists in providing loop bars, in both slabs being connected, which overlap (although over a length which is less than the minimum to secure the full transmission of forces from one bar to the other); the opposite loops create a central compressed nucleus in the joint where both bars are safely anchored (Figure 24). This is a problem which has appeared in other bridges with a composite deck, such as the Ting-Kau bridge in Hong-Kong or the river Cooper bridge in Charleston, and it has been solved in a similar way.

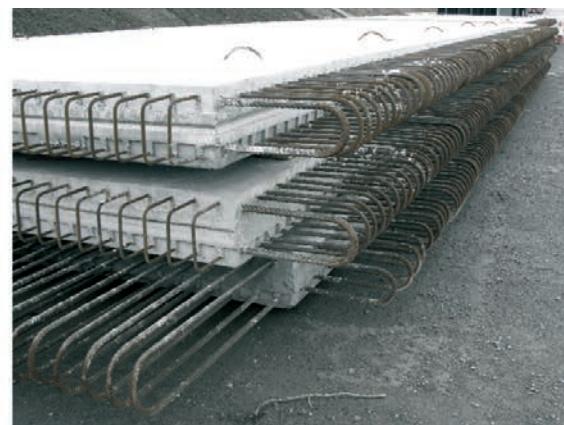
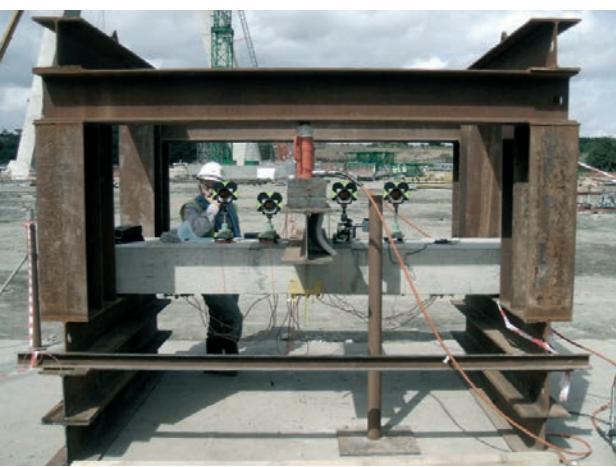
Figura 25. Ensayo de flexión en tres puntos de una junta de tablero
Figure 25. Three point bending test of a deck slab joint

Since this solution could not be checked by following the clauses of British Standards, neither in service nor in ultimate state, and, although there is some research work available about such kind of joints [8-10], it became necessary to test two of these joints to validate the design. The tests were carried out on two specimens of the slab which were subjected to a three point bending state of stress (Figure 25), which was considered representative of the actual state of stress in the joints. Interesting conclusions could be derived from these tests, for service as well as for ultimate states. At rupture, it was verified that the capacity of the joint is not less than that of a concrete slab with the same amount of reinforcement; then it was shown that the anchorage and overlapping of the loop bars was sufficient. The limit value of the load which was measured in the tests (Figure 26, where the initiation of cracking and rebar yielding have been marked) was almost coincident with the value which could be obtained by applying the

usual methods for checking reinforced concrete sections in bending. In service, it was shown that the most delicate sections are the interphases between the precast slabs and the cast in place stitches; this is due to the fact that this is the cross section with the lesser reinforcement and that the adherence is smaller in the interphase (as it may be seen on Figure 27, which corresponds to the ultimate load). The crack width values which were measured at the service load level were smaller than the allowable limit which is 0.25 mm according to British Standards.

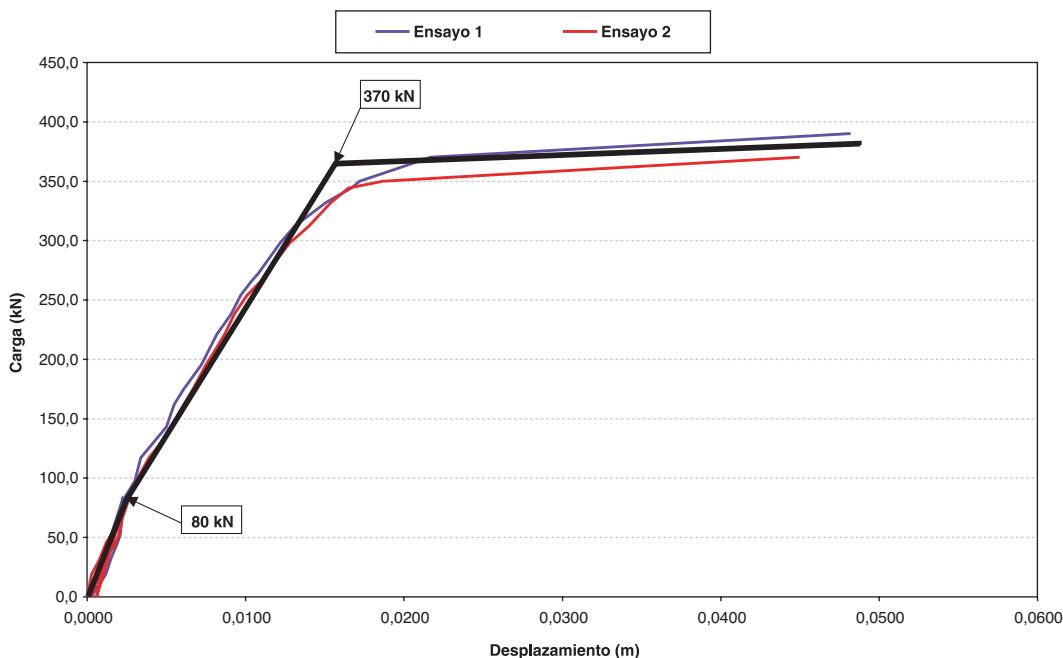
Figura 26. Curvas carga-desplazamiento obtenidas en los ensayos de juntas de losas prefabricadas
Figure 26. Load-displacement diagrams obtained in the tests of the precast slabs joints

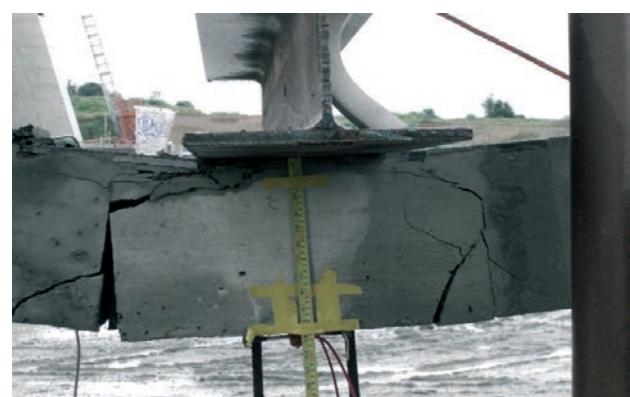
Figura 27. Junta entre losas prefabricadas después del ensayo.
Figure 27. Joint between precast slabs after the test.

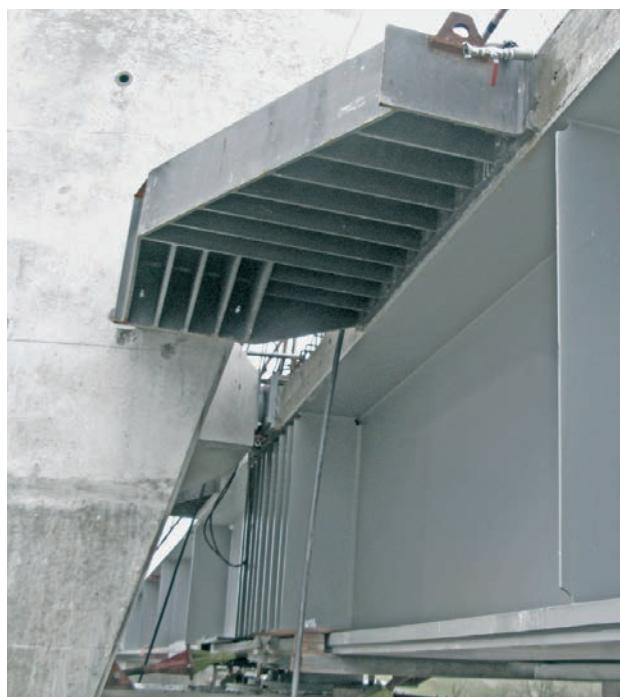
Figura 28. Tope de bloqueo del tablero en la torre
Figure 28. Corbel to block the deck movement at the pylon

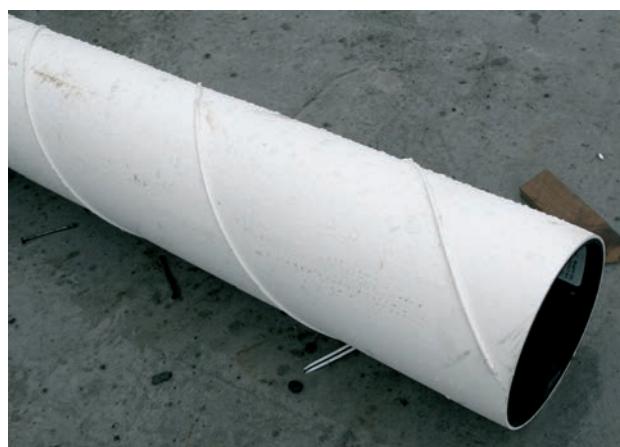
Figura 29. Vaina exterior de los tirantes
Figure 29. External sheath of the cables

Los tirantes están formados por cordones galvanizados y recubiertos por una funda de polietileno rellena

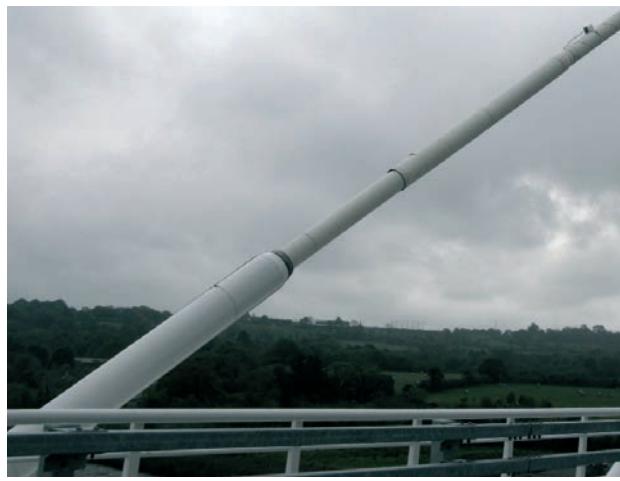
Figura 30. Tubo antivandálico y acelerómetro colocado en un tirante
Figure 30. Anti-vandalism tube and accelerometer installed on a cable

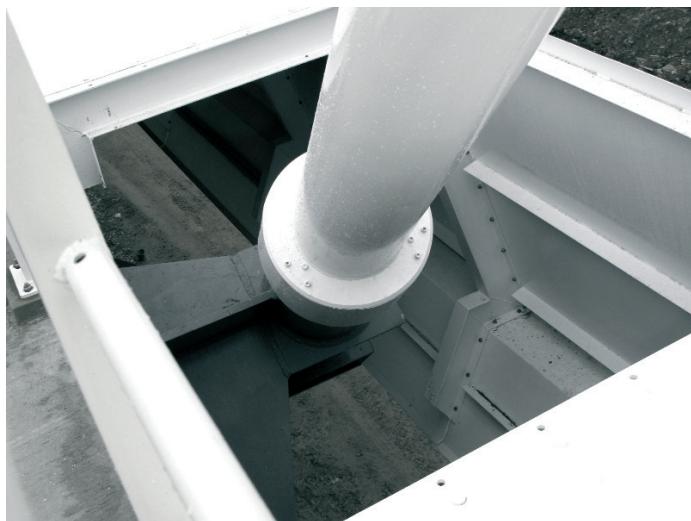
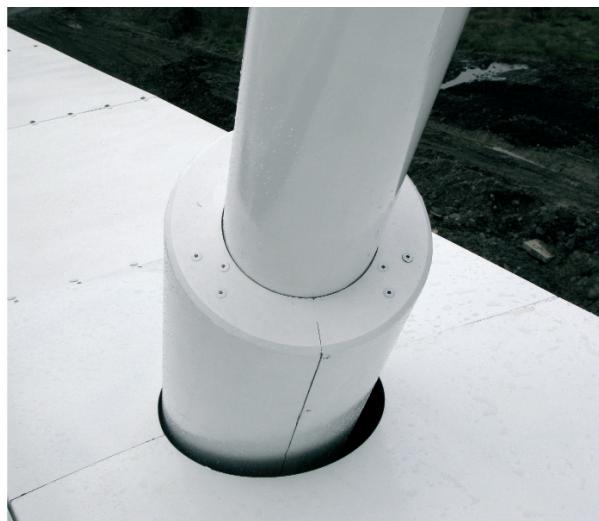
Figura 31. Imposta metálica.
Figure 31. Steel fascia beam.

The fascia beam is a very relevant element of the deck. The design conditions were that it had to hide totally the anchorages while leaving access to them for inspection and maintenance. The designed solution consists in a very light steel hull cantilevering from the concrete slab. It allows free access from below without any obstacle. The supporting structure is based on a series of ribs located at variable distances, around 2.30 m, which are anchored against the concrete slab by means of stainless steel bolts; the hull is made out of steel plates with elliptical holes for the cables (Figure 31).

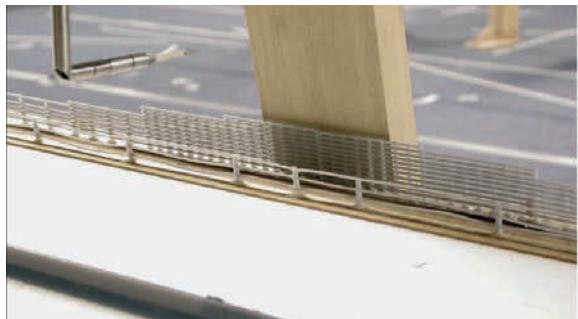
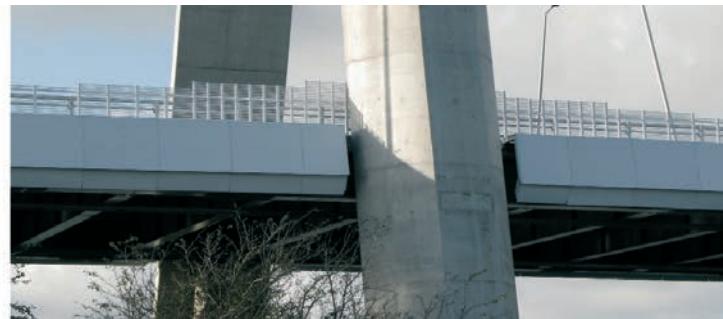
Figura 32. Barandilla alrededor de la torre (modelo y prototipo)
Figure 32. Pedestrian guardrail in the neighbourhood of the pylon (model and prototype)
