El puente atirantado sobre el río Suir en Waterford

Cable-stayed bridge across the River Suir at Waterford

Miguel A. Astiz⁽¹⁾, Javier Manterola⁽¹⁾, Felipe Tarquis⁽²⁾, Javier Muñoz-Rojas⁽³⁾, Antonio Santos⁽⁴⁾,
 Lucía Blanco⁽³⁾ y Sara Fernández⁽³⁾

The bridge across the river Suir at Waterford (Ireland) is a cable-stayed bridge with 465 m total length, a 230 m long main span and a single pylon. This bridge has a number of characteristics which make it singular: the use of high capacity micropiles in the foundations, an inverted Y-shaped pylon without any transverse beam at deck's level, the anchorage of the cables at the pylon by means of an internal steel structure, its composite deck which consists of a steel ladder shaped structure with two or four edge beams and cross beams and of precast ribbed concrete slabs, the variable width of the deck or the fact that there is only one expansion joint at one of the abutments, since the bridge is integral with the other abutment.

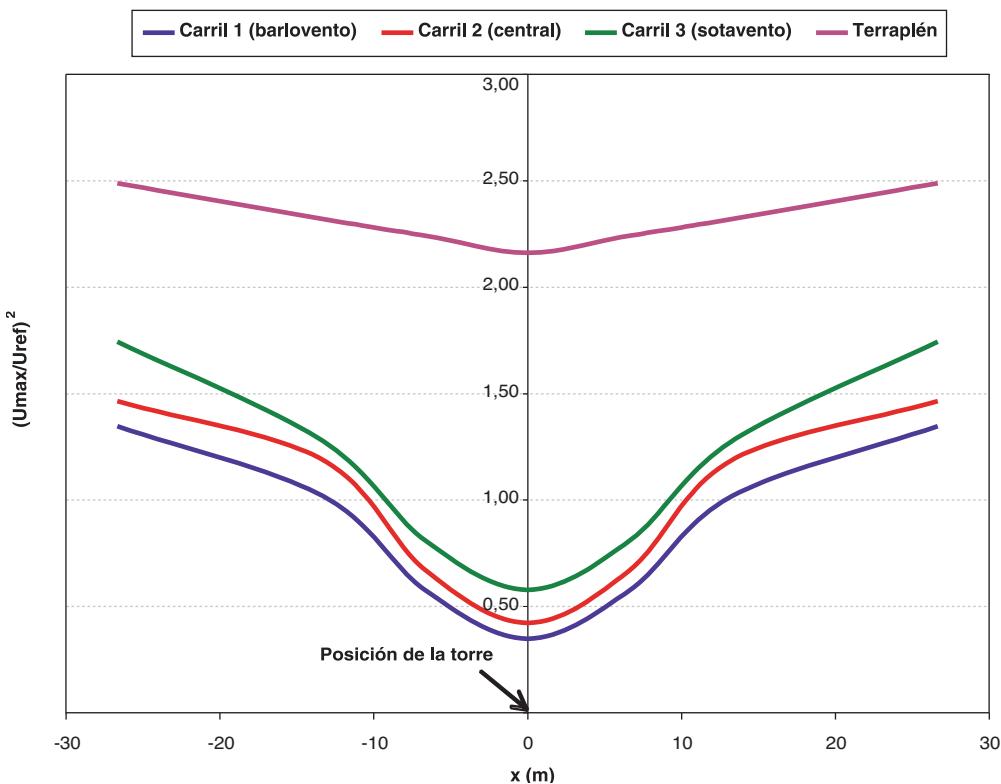
Figura 33. Variación de la acción del viento a lo largo del tablero al paso por la torre
Figure 33. Variation of wind action along the deck in the neighbourhood of the pylon

models of high and light vehicles, such as buses, and the conclusion was that the safety conditions for traffic were better than for the highest embankment of the motorway. This is an aspect which is still not well understood by the engineering community: high embankments may generate wind conditions which are very dangerous for traffic safety, even worse than the conditions on a bridge. Traffic stability under the pylon was also studied since the aerodynamic shape of the pylon legs may generate a very acute flow concentration and, consequently, a peak in transverse forces on vehicles using the bridge. To fight against this possibility the pedestrian guardrails were designed with a variable height and density in the neighbourhood of the pylon (Figure 32), in the same way as it was done years ago for the Severn bridge [11]. Figure 33 shows the variation of transverse forces along the bridge in three different lanes compared to the force variation in the highest embankment of the motorway.

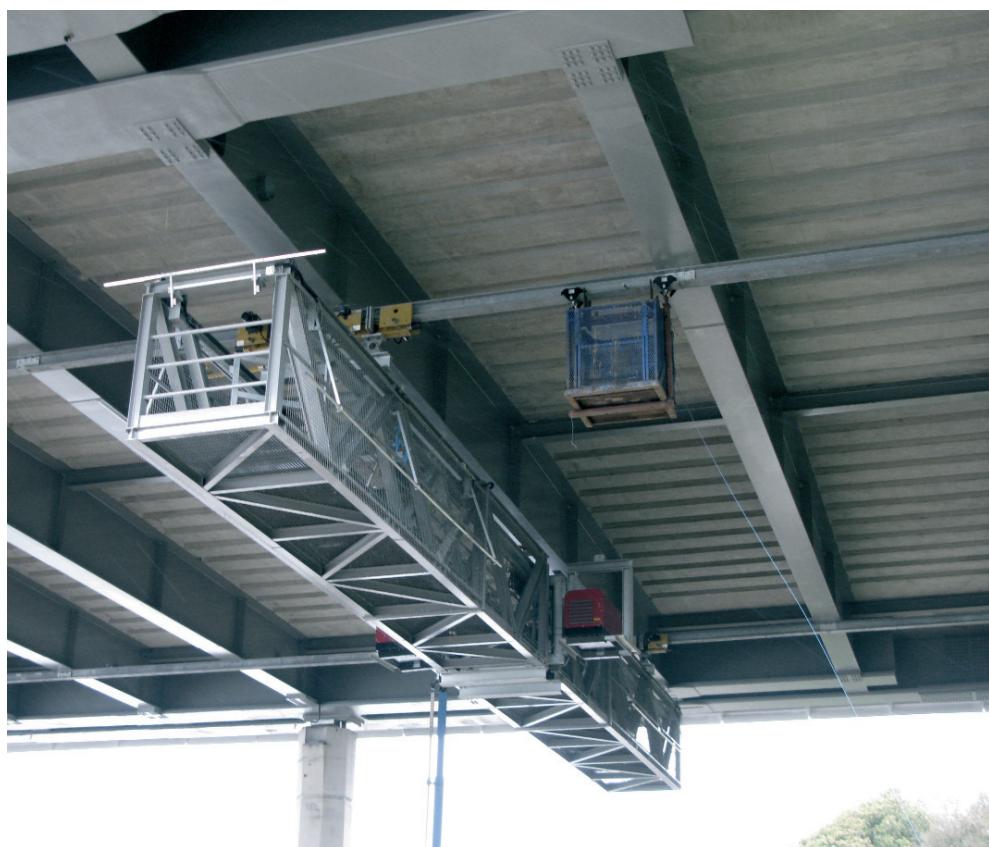
Figura 35. Carro de mantenimiento
Figure 35. Maintenance gantry

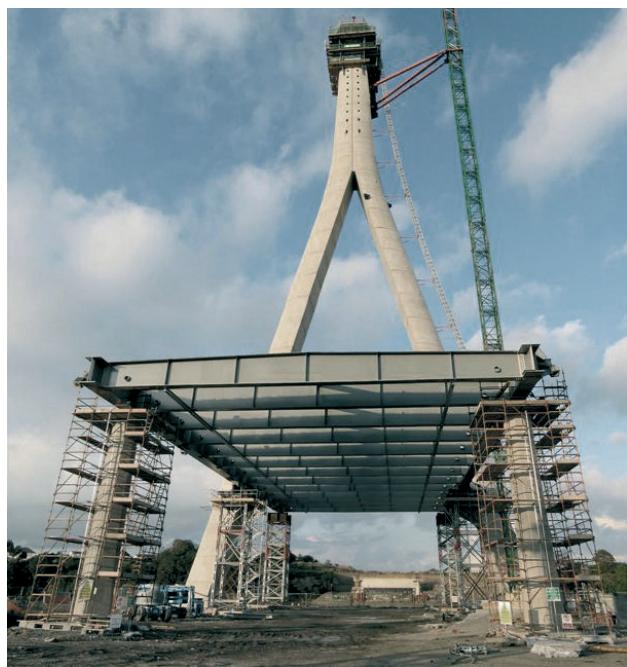
Figura 36. Montaje de estructura metálica en vanos traseros.
Figure 36. Installation of steel structure in back spans.

relative to construction is the deck. The steel structure was fabricated in Chepstow (Wales) and it was transported first by ship and then by road to the site. The edge girders (including the cable anchorages) came in 10 m long segments and the cross beams came complete. The back

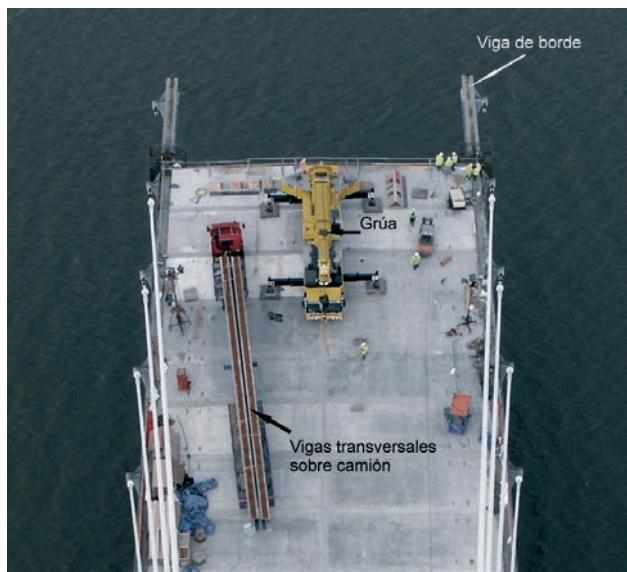
Figura 37. Montaje de estructura metálica en vanos delanteros
Figure 37. Installation of steel structure in main span

All the elements were transported along the deck and were installed by means of a crawler crane which was located at the front end of the cantilever (Figure 37 and Figure 38). The connection of steel elements by means of high strength friction bolts and the installation and stressing of cables were performed from ad-hoc cages which were supported on the edge girders. This procedure, which is based on the use of prefabricated elements, requires very few means and it minimizes the loads which are applied on the cantilever during deck erection. In this respect, the most critical moment corresponds to having the 10 m cantilever completed (including the full deck slab) just before stressing the front end cables. The geometrical adjustment was made when connecting the

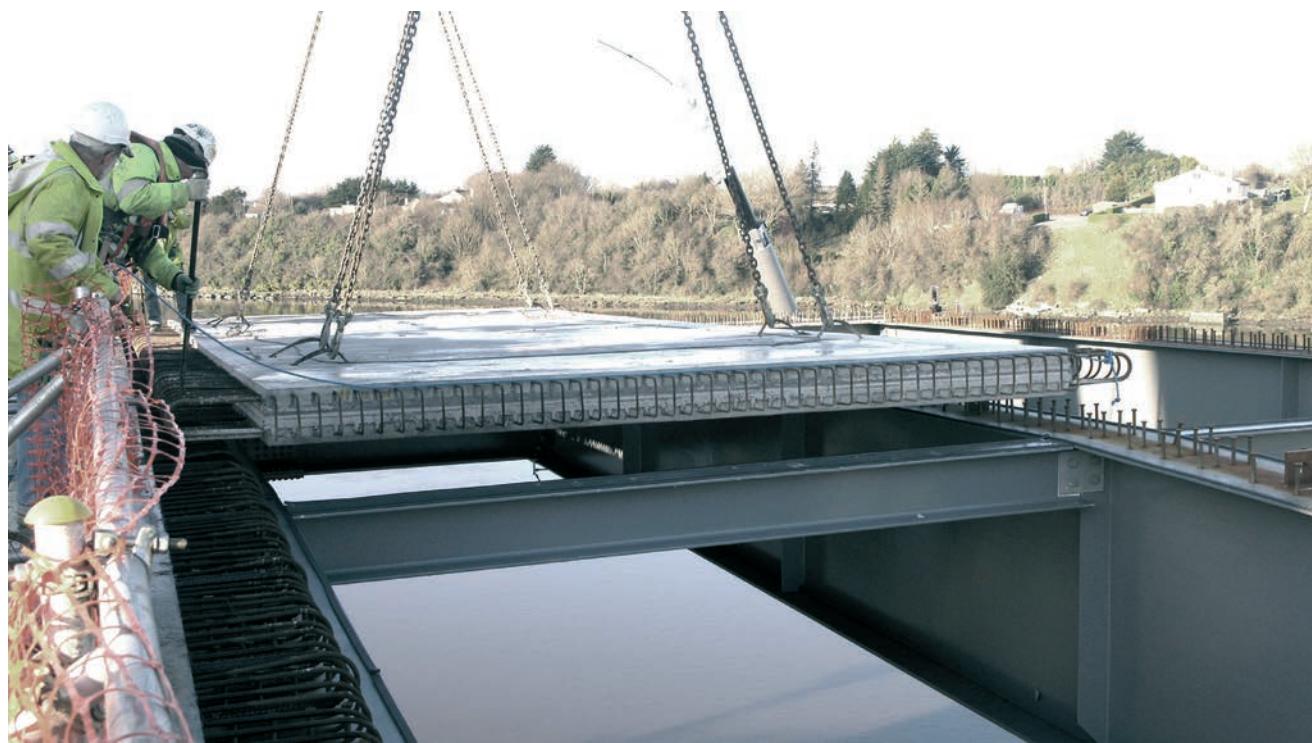
Figura 38. Colocación de losas prefabricadas
Figure 38. Installation of precast slabs

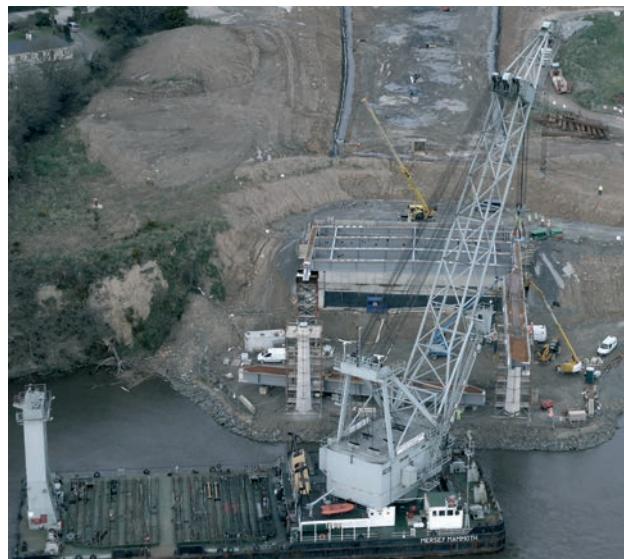
Figura 39. Colocación del tramo de espera mediante grúa flotante
Figure 39. Installation of the end span by a floating crane

El montaje del vano de espera en el extremo Norte del puente (estribo E2) fue especialmente complicado, debido al peso de las vigas de borde, unas 160 t (en esa zona son dobles y tienen una longitud de 36

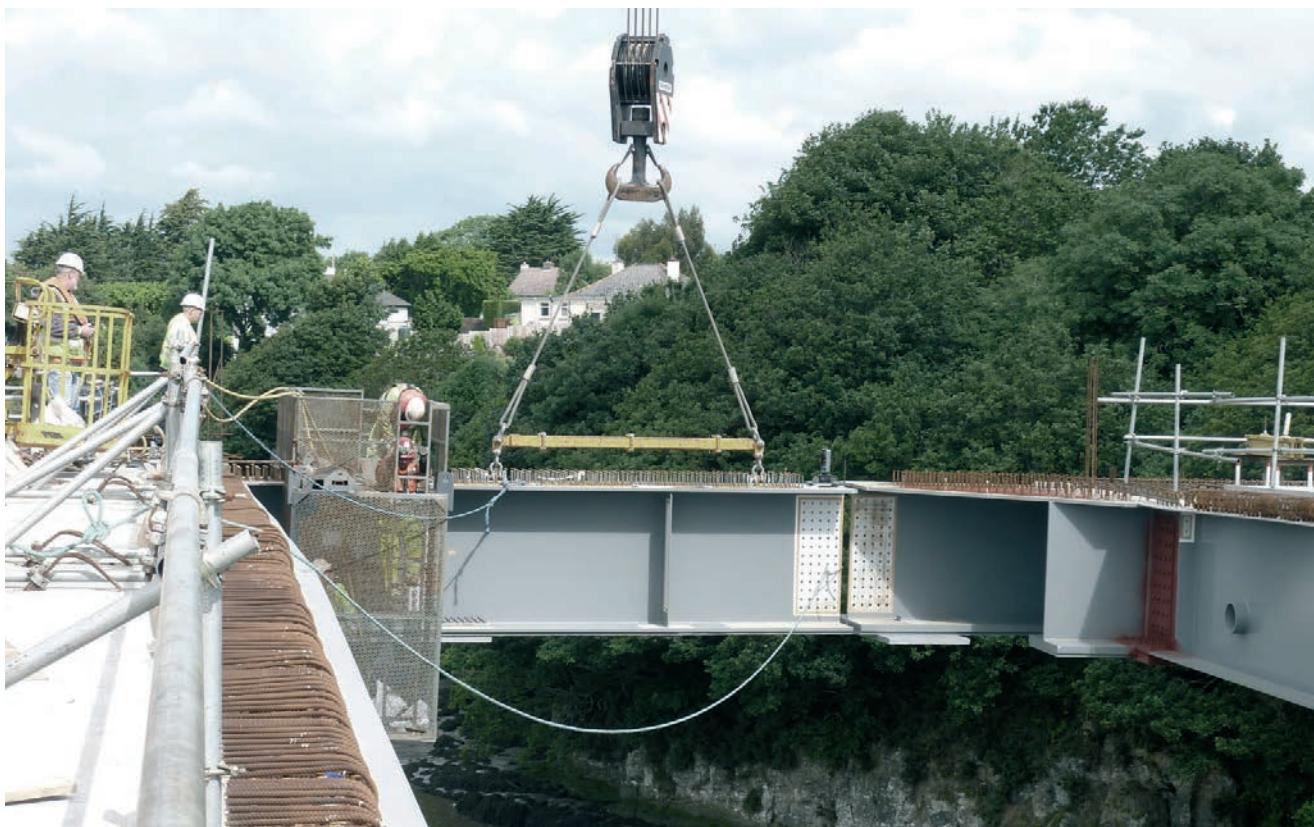
Figura 40. Colocación del tramo de cierre del vano.
Figure 40. Installation of the closing segment of the span.

El control geométrico y de cargas en los tirantes es fundamental en un puente de este tipo, lo que obliga a referir en cada fase las medidas de coordenadas a las previsiones de los cálculos. Como consecuencia de dicho control, la colocación del tramo de cierre

del vano se llevó a cabo sin mayores problemas (Figura 40).
