El puente atirantado sobre el río Suir en Waterford

Cable-stayed bridge across the River Suir at Waterford

Miguel A. Astiz⁽¹⁾, Javier Manterola⁽¹⁾, Felipe Tarquis⁽²⁾, Javier Muñoz-Rojas⁽³⁾, Antonio Santos⁽⁴⁾,
Lucía Blanco⁽³⁾ y Sara Fernández⁽³⁾

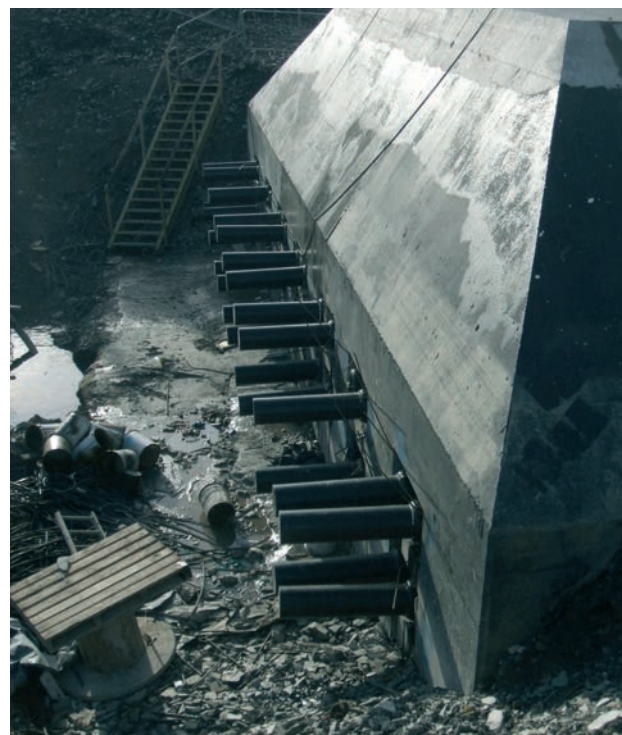
Figura 8. Anclajes del pretensado de la viga de atado
Figure 8. Anchorages for the tie beam prestressing

Nevertheless it is still necessary to connect both legs foundations by means of a tie beam to reduce the horizontal reactions on these foundations. This tie beam, which is basically supporting tension forces, is longitudinally prestressed (Figure 8) and it is being supported at midspan on two micropiles since it is so slender that it could not resist the dead weight bending moments which

Because of the caution existing in British engineering community against interior prestressing, prestressing was designed as non adherent with wax filled polyethylene sheaths. The cables were electrically isolated from the anchorage plates and the possibility was left for the substitution of any strand in the future if, during an inspection, some movement of the foundations is detected. In addition, four more sheaths were installed (empty and sealed) to let the possibility of adding four more prestressing cables to the tie beam. The inspection of the tie beam is performed by means of 16 vibrating wire extensometers whose data are recorded in a continuous manner. If the foreseen values were surpassed at any time, an alarm would be generated to inform the bridge operator who would ask for correcting steps.

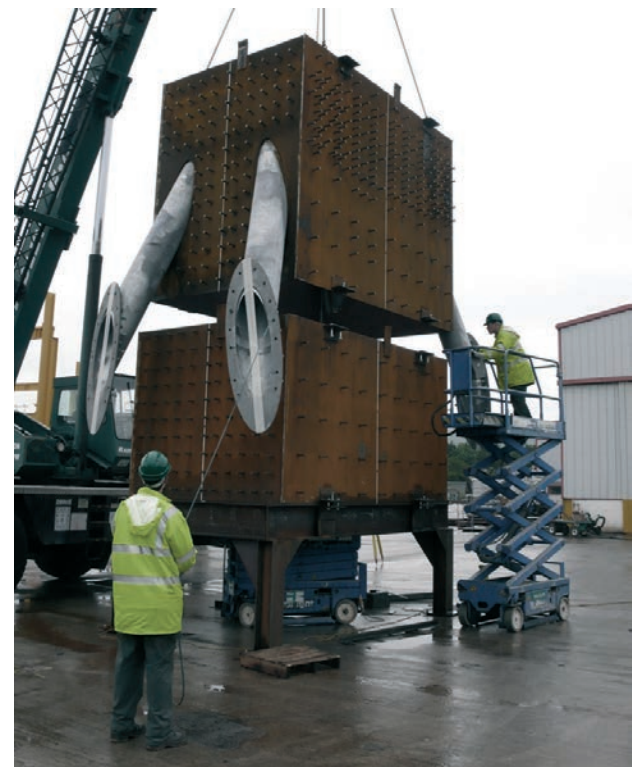
Figura 11. Montaje en blanco de cajones en taller
Figure 11. Trial assembly of the boxes at workshop

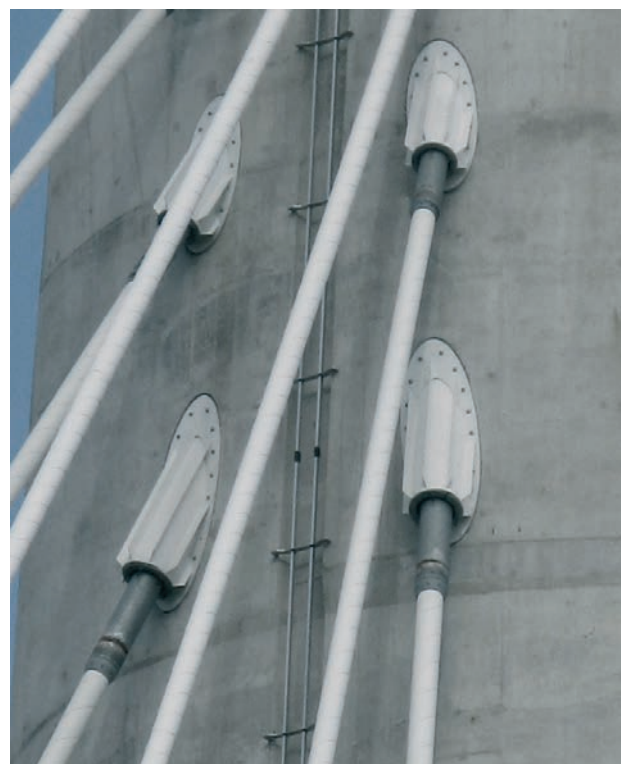
Figura 12. Tubos de tirantes en el exterior de la torre
Figure 12. Cable tubes outside the pylon

Los cajones llevan incorporado el tubo por el que se introduce el tirante, que no tiene misión estructural, sino sólo de encofrado. Estos tubos se rematan mediante una chapa elíptica, de tal forma que el conjunto quede en el interior del encofrado de la torre. De esta manera no es necesario perforar el encofrado y las operaciones de hormigonado de la torre se facilitan notablemente. Una vez construida la torre, los tubos se prolongan mediante otros tubos también rematados con una chapa elíptica gemela de la anterior, que se atornilla a ésta (Figura 12). La longitud de los tubos exteriores es la necesaria para contener el centrador del tirante. Estos tubos llevan unos rigidizadores radiales para reducir los problemas de fatiga producidos por las acciones de viento sobre los tirantes. Con el mismo fin de no alterar los encofrados, las ménsulas de apoyo del tablero se

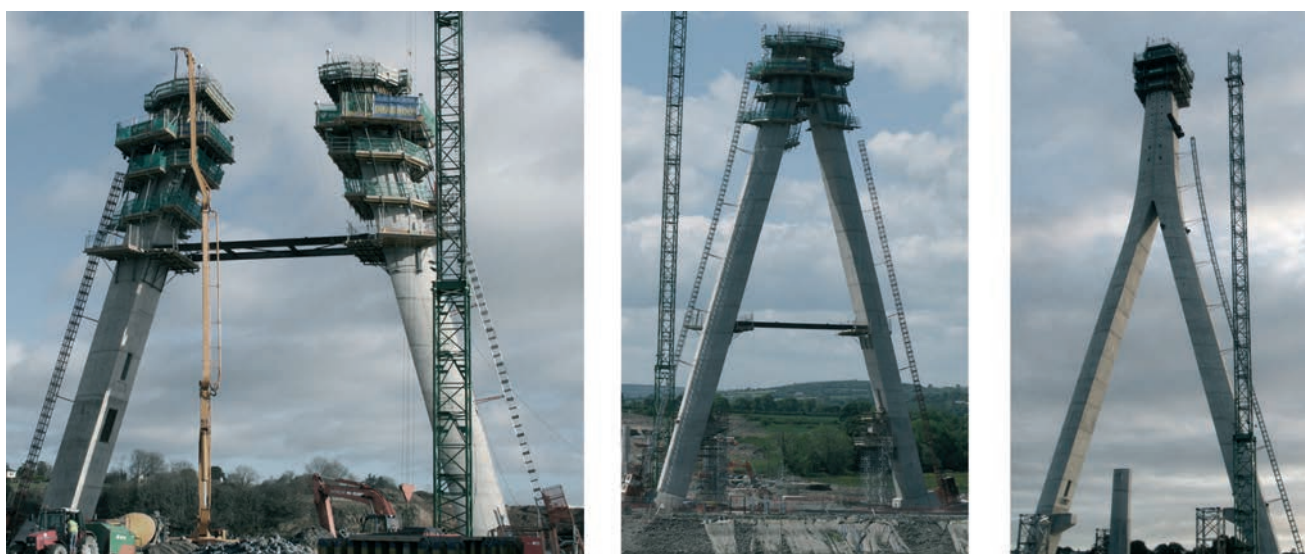
Figura 13. Distintas fases de construcción de la torre
Figure 13. Different stages in the construction of the pylon

The pylon was erected by means of a climbing formwork with 4 m high trips. Besides the external surface is curved, as the curved profile stays constant, it was only necessary

La construcción de la torre se realizó mediante encofrado trepador en trepas de 4 m. Aunque la superficie exterior es curva, dado que el perfil curvo de la sección transversal se mantiene constante, sólo resultó necesario desmontar los encofrados en la zona de transición de patas a mástil, de directriz también curva, como se ha indicado anteriormente. La inclinación de las patas obligó a apuntalar una contra la otra mediante dos puntales horizontales, para limitar las flexiones en dichas patas (Figura 13). Uno de los puntales se situó a media altura y el otro en la intersección entre las patas.

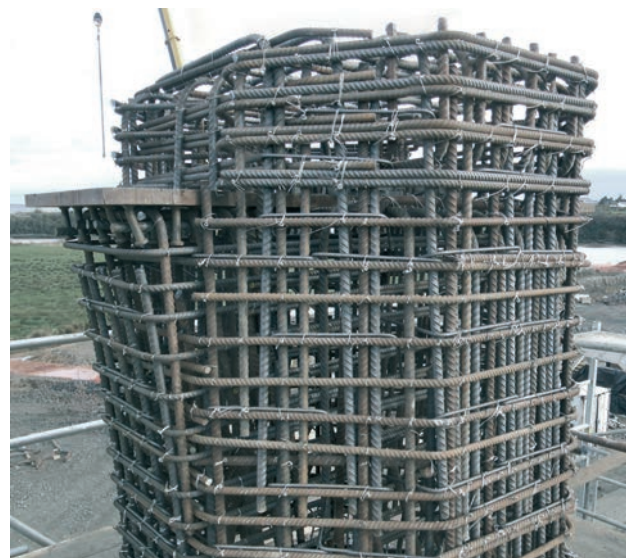
Figura 15. Armado de la cabeza de una pila
Figure 15. Reinforcement of one pier

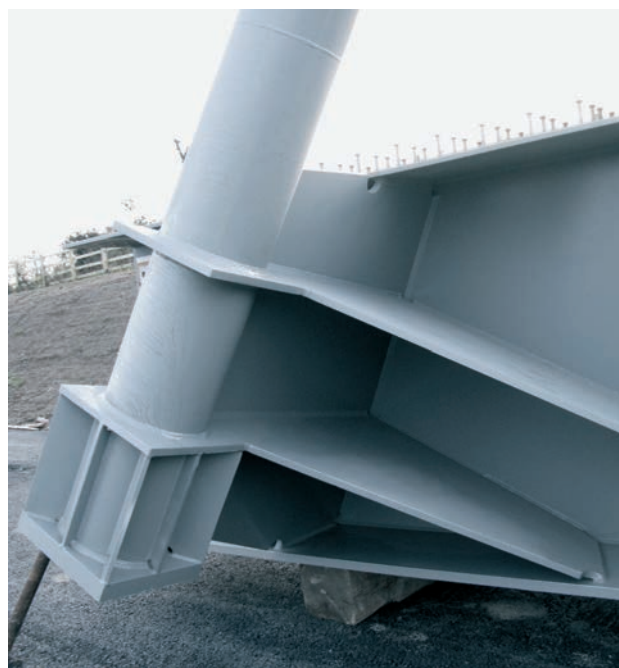
Figura 20. Anclaje de un tirante en el tablero
Figure 20. Deck anchorage of a cable

Para anclar los cables contra una prolongación de las almas de las vigas longitudinales hubiera sido necesario aumentar inútilmente la anchura del puente en toda su longitud. Por ello se optó por la solución de anclar los cables contra unas estructuras metálicas que vuelan por fuera de las vigas longitudinales de borde y tapar dichos anclajes con la imposta. La

estructura de soporte del anclaje consiste en un tubo estructural que recibe la carga de la placa de anclaje y la transmite al tablero mediante una chapa soldada a una de las generatrices del tubo y al alma y alas de la viga longitudinal de borde (Figura 20). Esta chapa se rigidiza con dos placas transversales que se sueldan también al tubo para transmitir al tablero las cargas transversales (fundamentalmente de viento) impuestas por el cable. La fabricación de estos anclajes exigió un trabajo muy fino de replanteo (esta estructura define el ángulo de salida del tirante) y control de soldaduras y en el proyecto hubo que recurrir a modelos de elementos finitos como el que se muestra en la Figura 21. En esta figura se puede

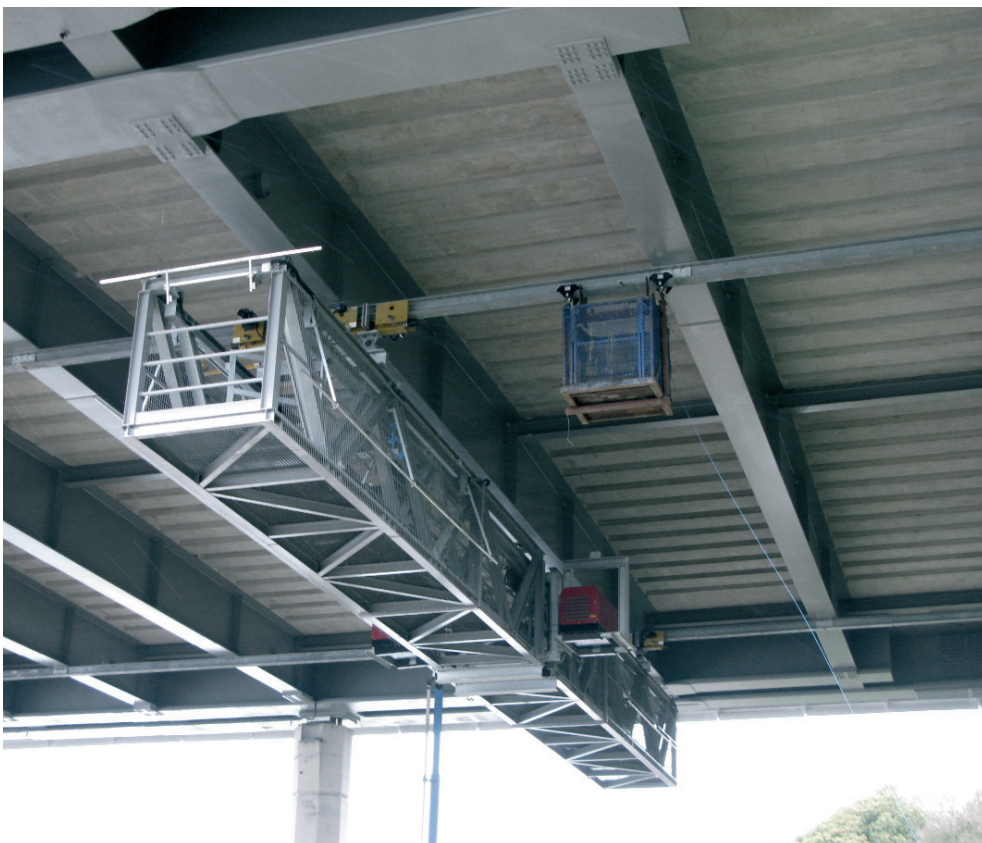
Figura 35. Carro de mantenimiento
Figure 35. Maintenance gantry

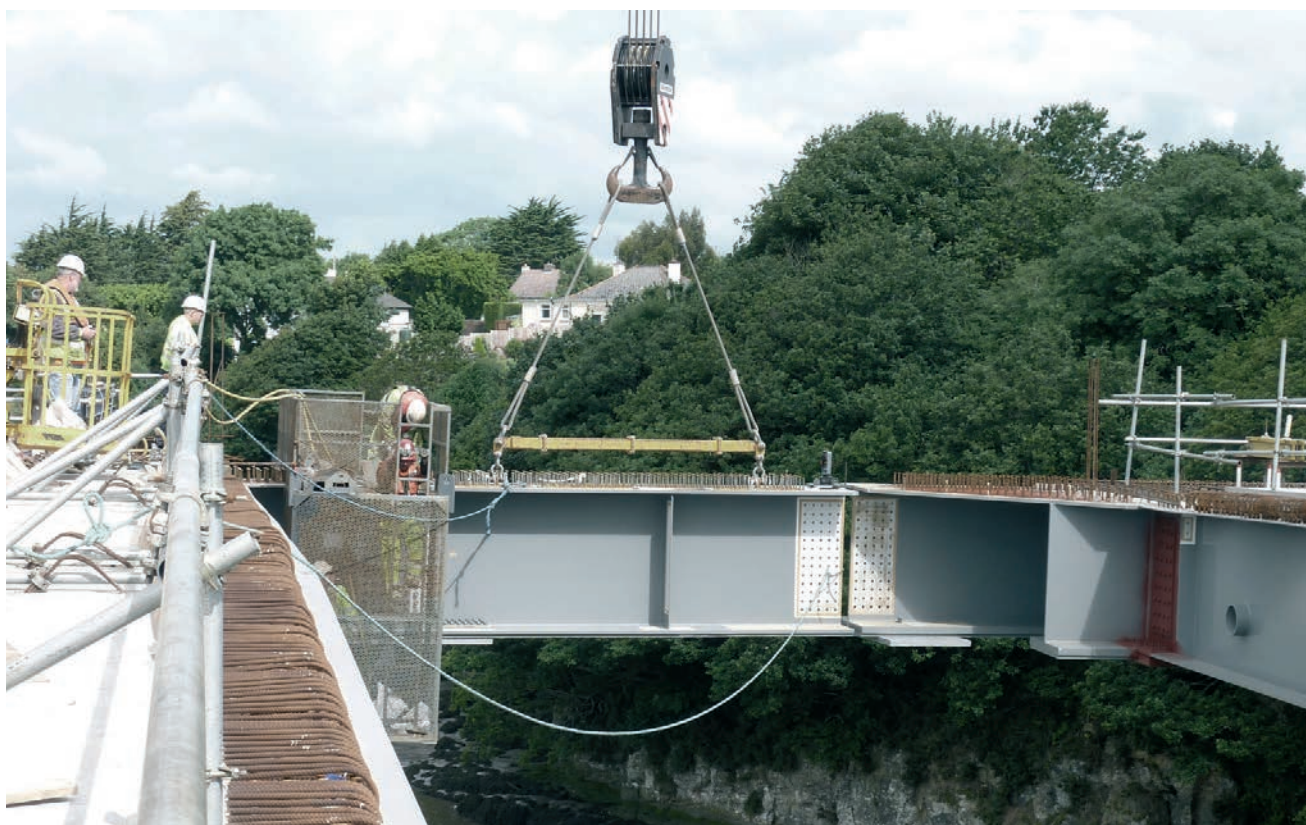
Figura 40. Colocación del tramo de cierre del vano.
Figure 40. Installation of the closing segment of the span.

El control geométrico y de cargas en los tirantes es fundamental en un puente de este tipo, lo que obliga a referir en cada fase las medidas de coordenadas a las previsiones de los cálculos. Como consecuencia de dicho control, la colocación del tramo de cierre
