El puente atirantado sobre el río Suir en Waterford

Cable-stayed bridge across the River Suir at Waterford

Miguel A. Astiz⁽¹⁾, Javier Manterola⁽¹⁾, Felipe Tarquis⁽²⁾, Javier Muñoz-Rojas⁽³⁾, Antonio Santos⁽⁴⁾,
Lucía Blanco⁽³⁾ y Sara Fernández⁽³⁾

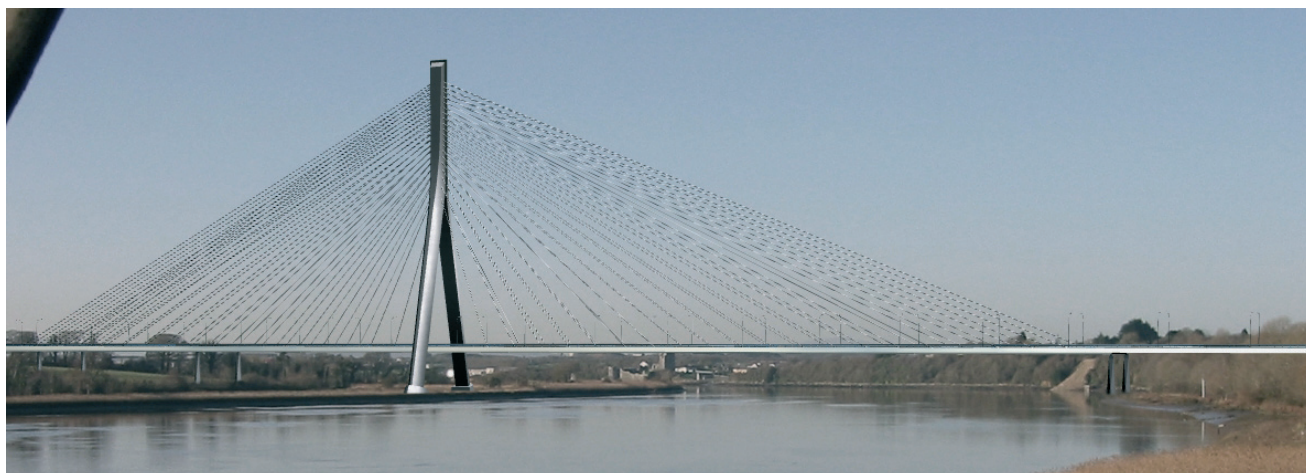
Figura 3. Imagen fotorrealista de la propuesta de concurso.
 Figure 3. Photorealistic image of the bidding proposal.

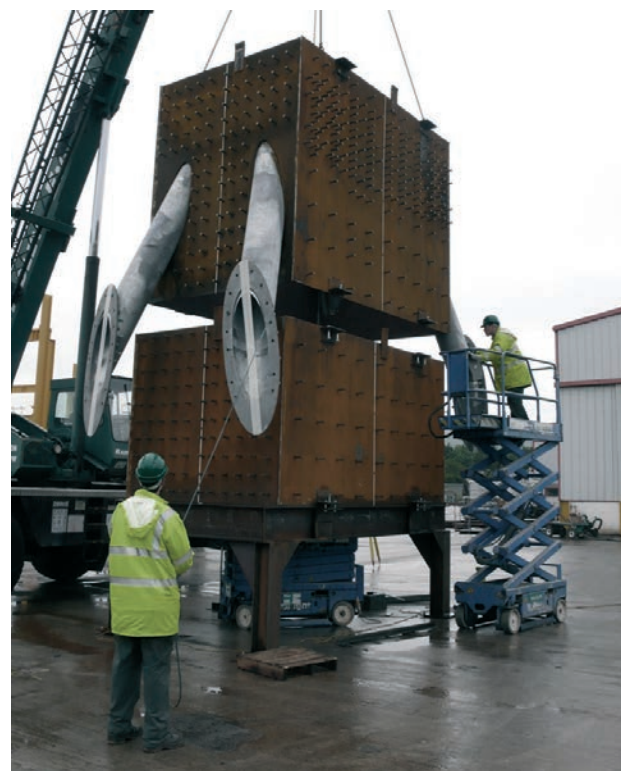
Figura 11. Montaje en blanco de cajones en taller
Figure 11. Trial assembly of the boxes at workshop

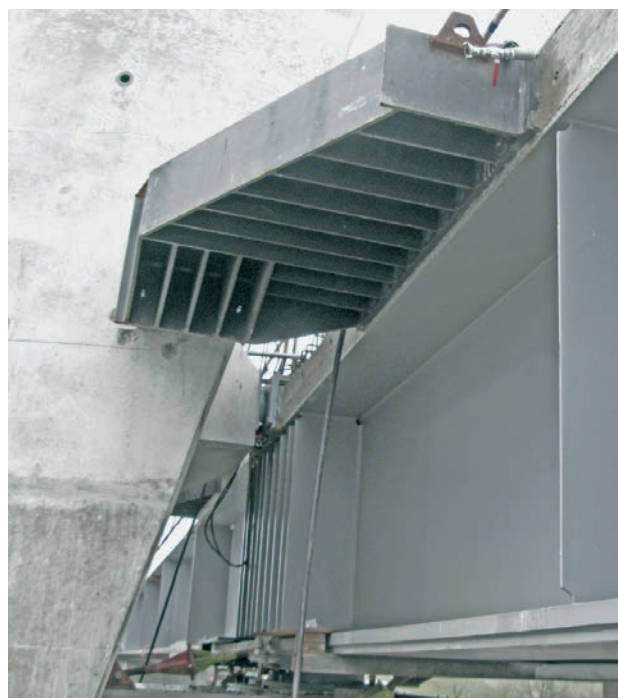
Figura 28. Tope de bloqueo del tablero en la torre
Figure 28. Corbel to block the deck movement at the pylon

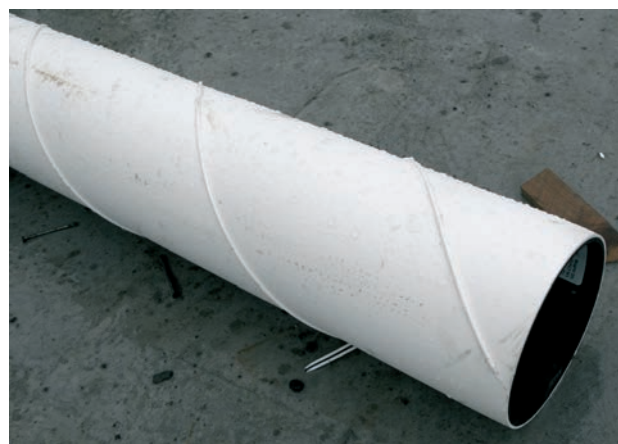
Figura 29. Vaina exterior de los tirantes
Figure 29. External sheath of the cables

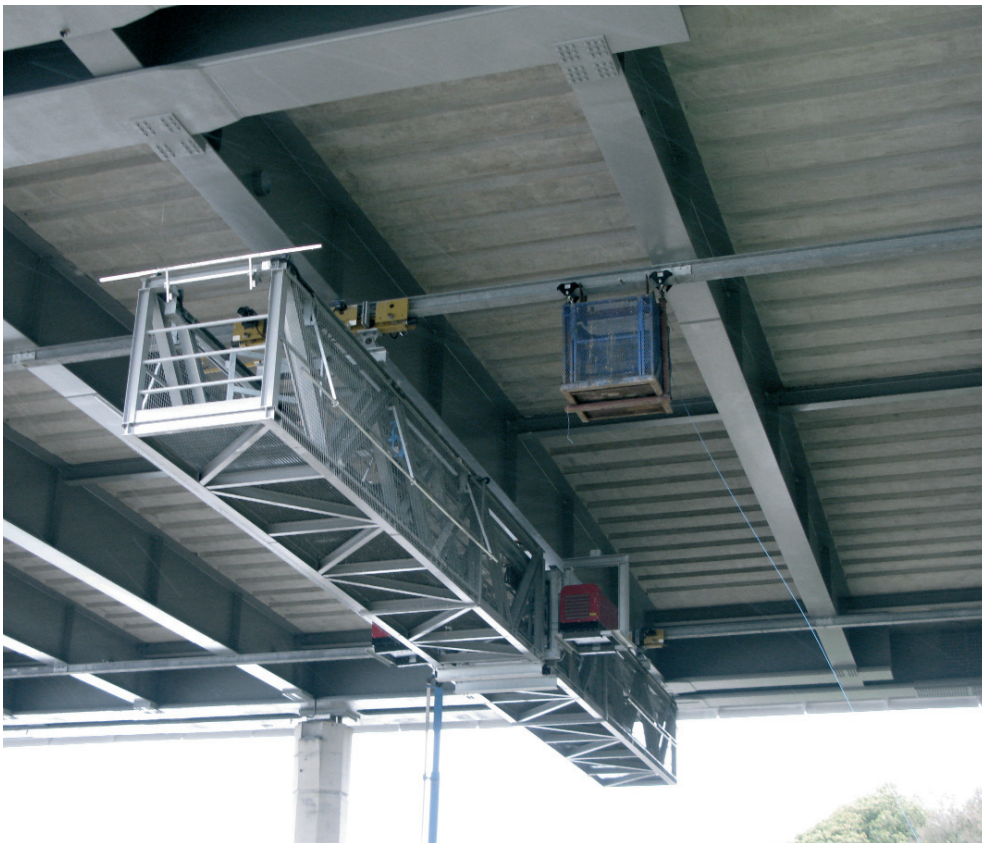
Figura 35. Carro de mantenimiento
Figure 35. Maintenance gantry

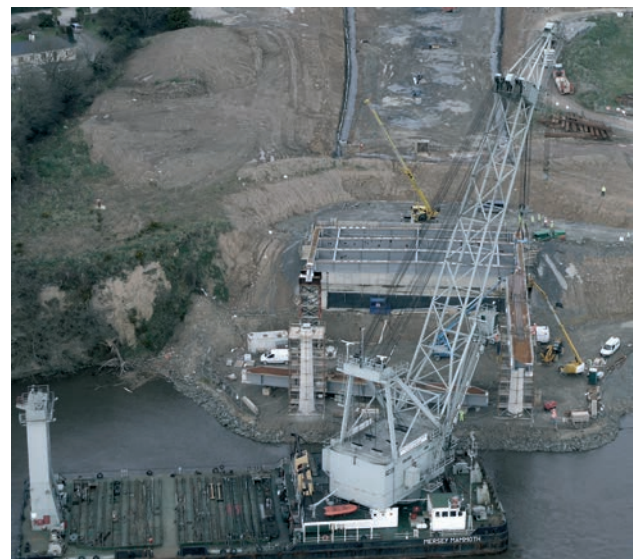
Figura 39. Colocación del tramo de espera mediante grúa flotante
Figure 39. Installation of the end span by a floating crane

El montaje del vano de espera en el extremo Norte del puente (estribo E2) fue especialmente complicado, debido al peso de las vigas de borde, unas 160 t (en esa zona son dobles y tienen una longitud de 36
