Puente sobre el río Tajo, en el embalse de Alcántara («Arcos de Alconétar»)

Bridge over the river Tagus at Alcántara Reservoir («Arcos de Alconétar»)

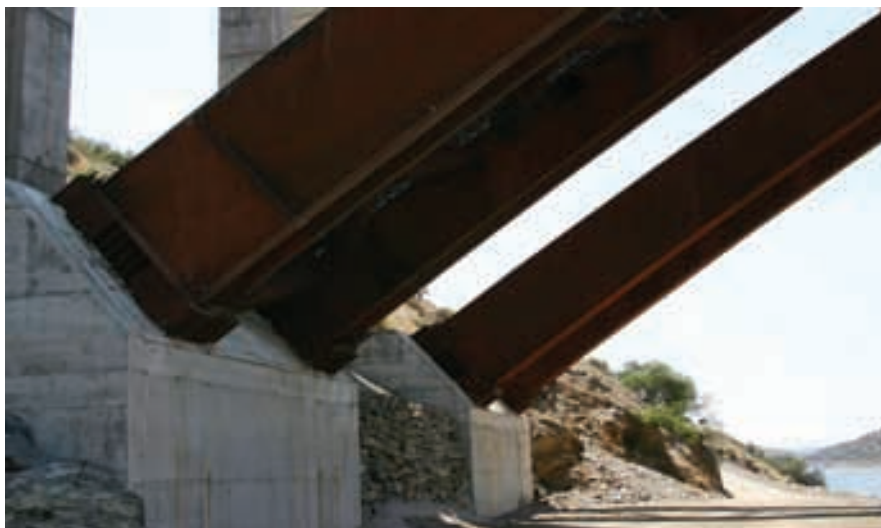
Figura 10. Empotramiento del arco.
Figure 10. Arch fixing.

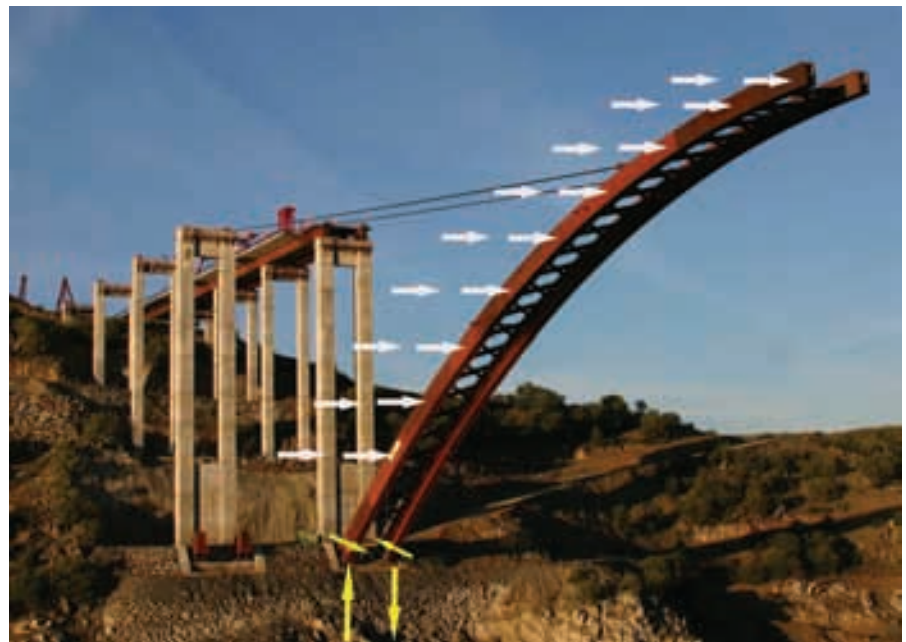
Figura 50. Efecto del viento lateral sobre un semiarco durante la maniobra de abatimiento.
 Figure 50. Side wind effect on one semi-arch during the swivel lowering operation.

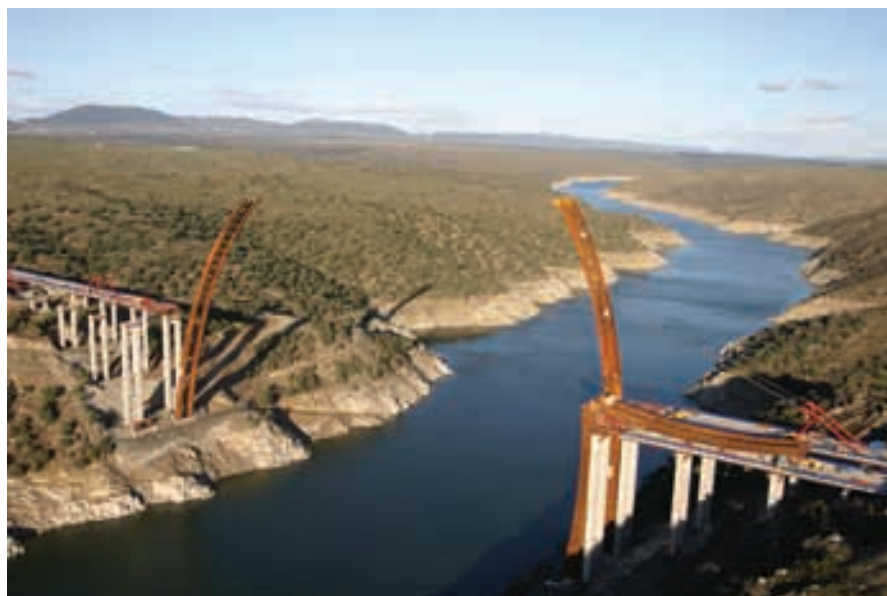
Figura 55. Embalse de Alcántara. Perspectiva general de la zona
Situación de la obra con semiarcos en posición vertical.
Figure 55. Alcántara Reservoir. General perspective of the area.
Location of the construction with semi-arches in vertical position.

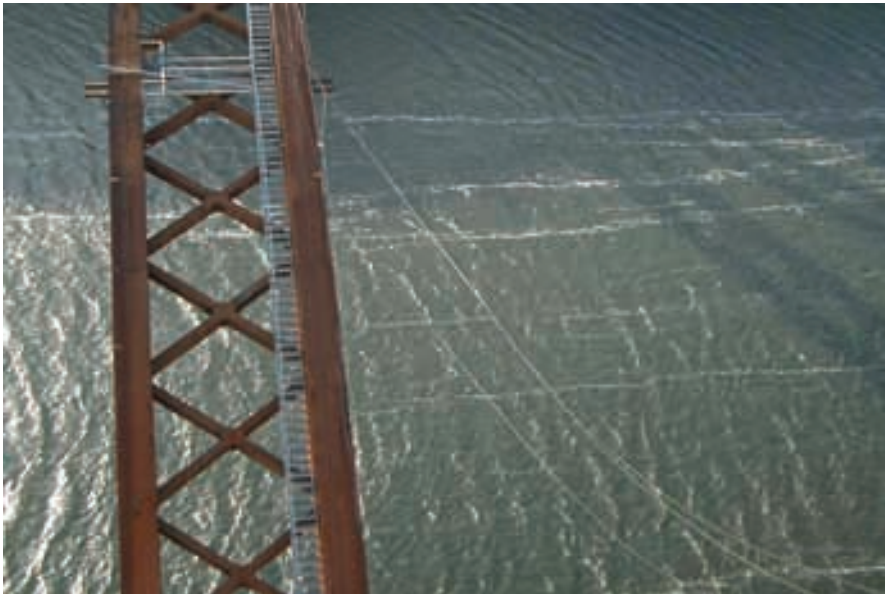
Figura 56. Estelas sobre la superficie del agua del embalse provocadas por viento estacionario
 Figure 56. Wakes on the reservoir's water surface caused by stationary wind.
